Project: RIVERBEND OF NAPLES SANITARY

11.29.2023

Pipe Segment Reference: MH-1B - MH-1
Upstream MH: 1B
Downstream MH: 1
Direction of Survey: Downstream
Material: Polyvinyl Chloride

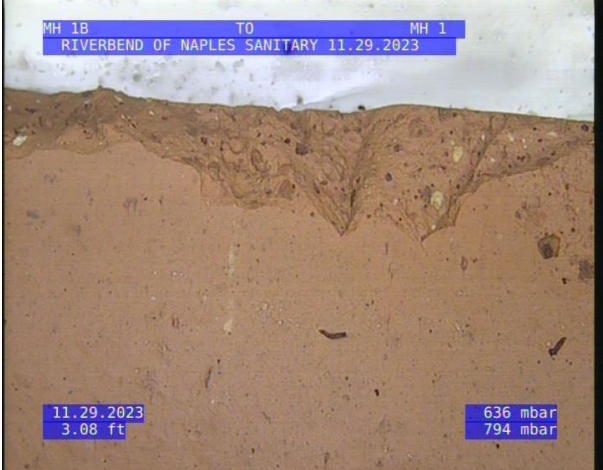
Distance	Fault Observation	Time	Picture
3.1	<p>Material Change Severity: None Remarks: VCP</p>	03:21

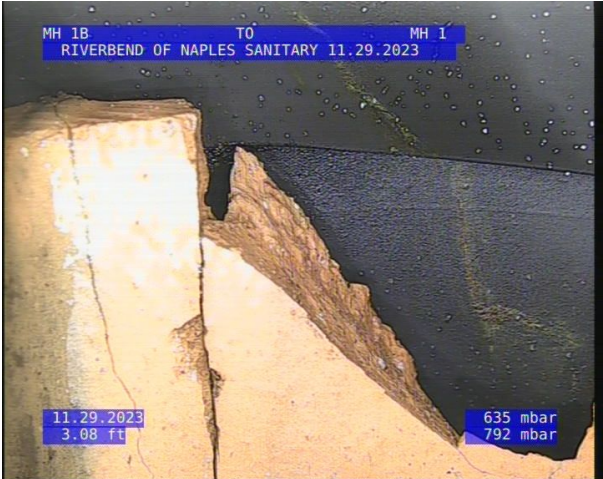
<p>MH 1B TO MH 1 RIVERBEND OF NAPLES SANITARY 11.29.2023</p> <p>11.29.2023 3.08 ft 636 mbar 794 mbar</p>
3.1	<p>Broken Position: 8 To 10 Severity: None Joint Struct Weight: 5</p>	04:09

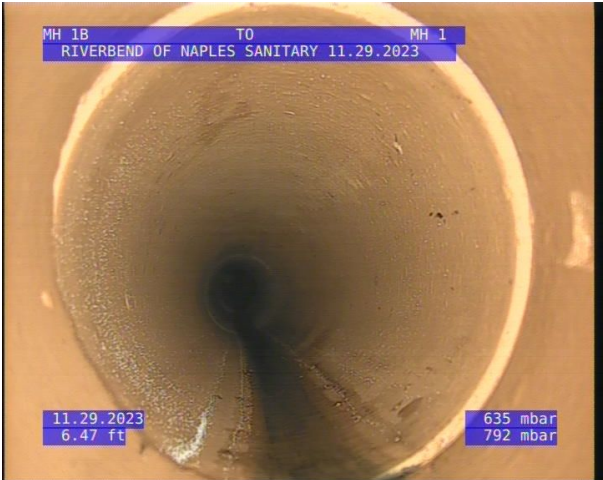
<p>MH 1B TO MH 1 RIVERBEND OF NAPLES SANITARY 11.29.2023</p> <p>11.29.2023 3.08 ft 635 mbar 792 mbar</p>
6.5	<p>Water Level Sag Severity: None Cont Defect: F01 Percent: 5 Struct Weight: 2</p>	04:48

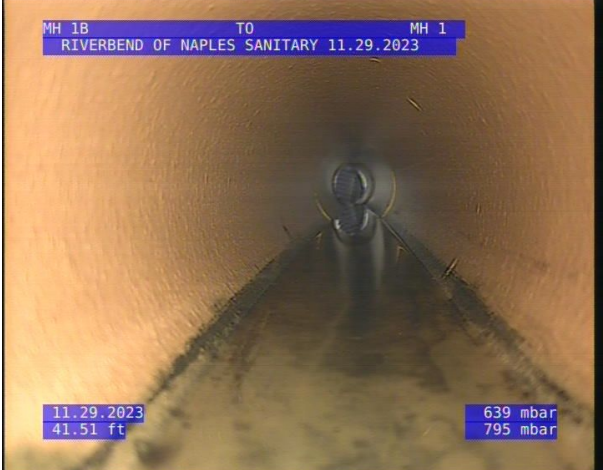
Distance	Fault Observation	Time	Picture
41.5	<p>Water Level Sag Severity: None Cont Defect: S02 Percent: 5 Struct Weight: 2</p>	06:48

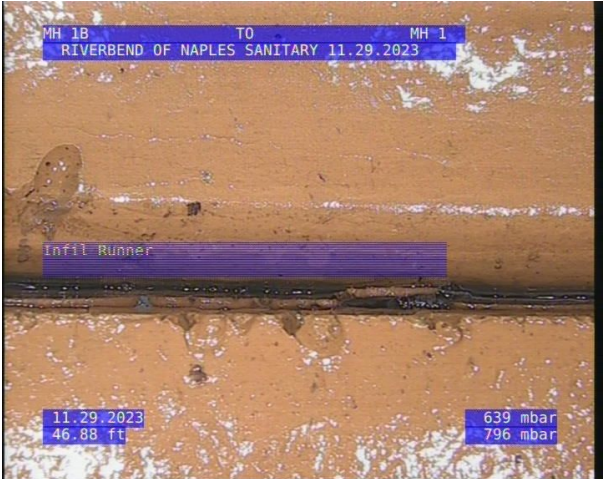
46.9	<p>Infil Runner Position: 6 To 11 Severity: None Joint Maint Weight: 4</p>	08:03

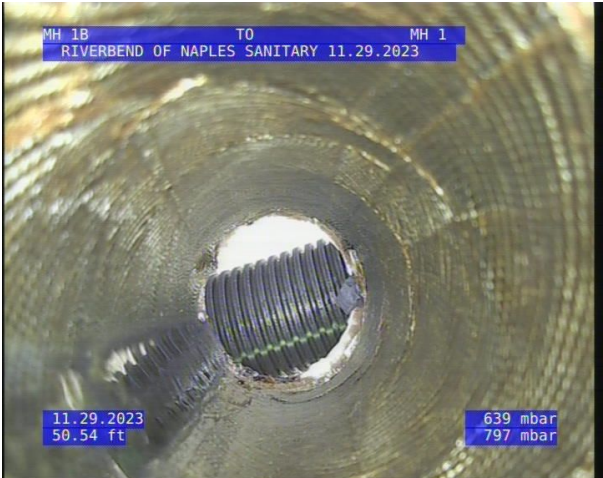
50.5	<p>Water Level Sag Severity: None Cont Defect: F02 Percent: 5 Struct Weight: 2</p>	08:59

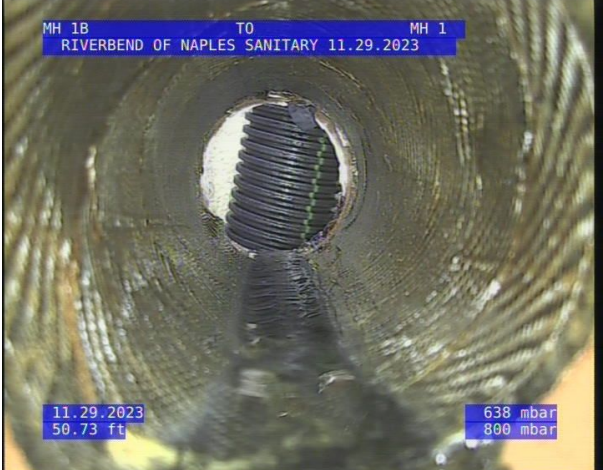
Distance	Fault Observation	Time	Picture
50.7	<p align="center">Repair Localized Liner Severity: None Remarks: LINNER</p>	11:33
