# Project: RIVERBEND OF NAPLES SANITARY

## 11.29.2023

**Pipe Segment Reference:** MH 1B - C/O-2  
**Upstream MH:** C/O 2  
**Downstream MH:** 1B  
**Direction of Survey:** Upstream  
**Material:** Vitrified Clay Pipe

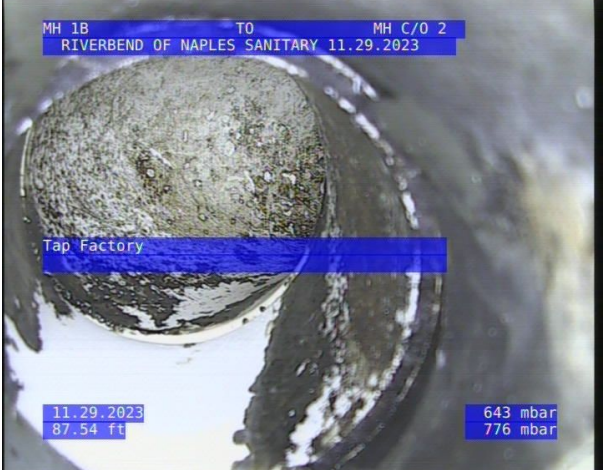
Distance	Fault Observation	Time	Picture
87.5	<p style="text-align: center;"> <b>Tap Factory</b>  <b>Position: 12</b>  <b>Severity: None</b>  <b>Size: 6</b> </p>	12:23

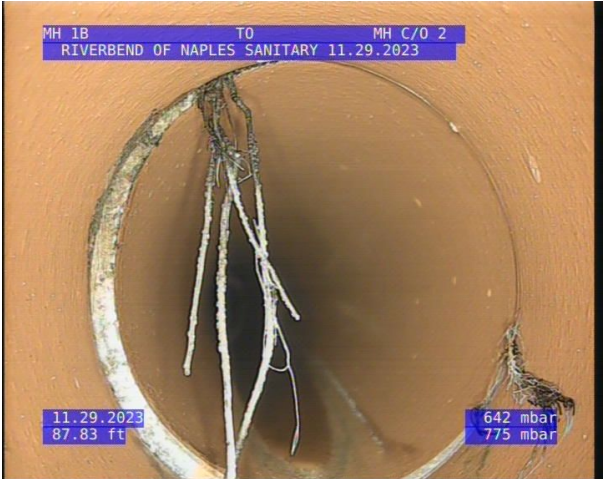
<p>MH 1B TO MH C/O 2 RIVERBEND OF NAPLES SANITARY 11.29.2023</p> <p>Tap Factory</p> <p>11.29.2023 87.54 ft</p> <p>643 mbar 776 mbar</p>
87.8	<p style="text-align: center;"> <b>Roots Fine Joint</b>  <b>Position: 10 To 4</b>  <b>Severity: None</b>  <b>Joint</b>  <b>Maint Weight: 1</b> </p>	13:13

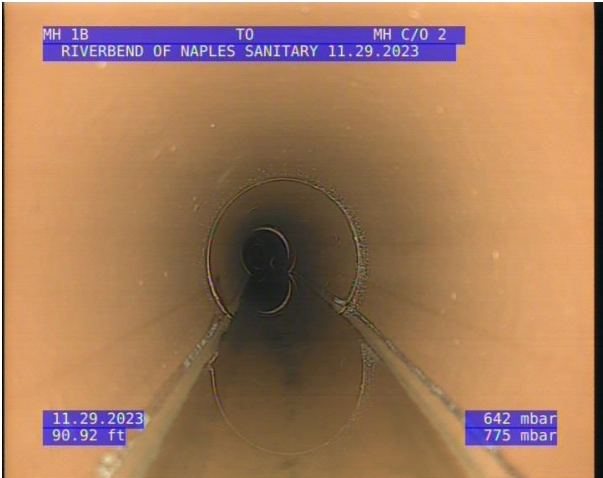
<p>MH 1B TO MH C/O 2 RIVERBEND OF NAPLES SANITARY 11.29.2023</p> <p>11.29.2023 87.83 ft</p> <p>642 mbar 775 mbar</p>
90.9	<p style="text-align: center;"> <b>Water Level Sag</b>  <b>Severity: None</b>  <b>Cont Defect: S02</b>  <b>Percent: 5</b>  <b>Struct Weight: 2</b> </p>	14:01

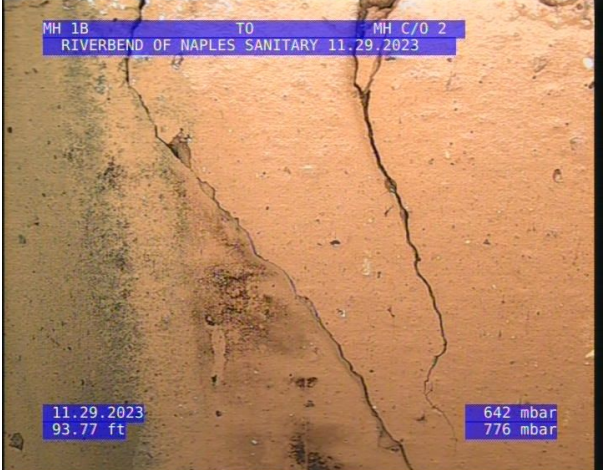
Distance	Fault Observation	Time	Picture
93.8	<p><b>Crack Longitudinal</b>  <b>Position: 8</b>  <b>Severity: None</b>  <b>Struct Weight: 2</b></p>	14:52

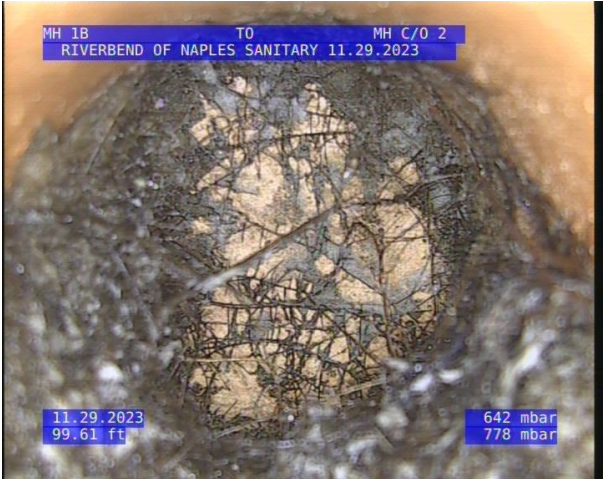
<p>MH 1B TO MH C/O 2  RIVERBEND OF NAPLES SANITARY 11.29.2023</p> <p>11.29.2023 93.77 ft 642 mbar 776 mbar</p>
99.6	<p><b>Tap Factory</b>  <b>Position: 12</b>  <b>Severity: None</b>  <b>Size: 6</b>  <b>Remarks: ROOTS</b></p>	15:57

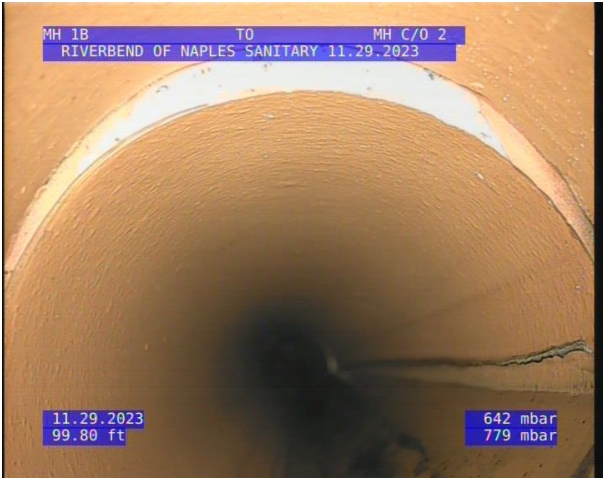
<p>MH 1B TO MH C/O 2  RIVERBEND OF NAPLES SANITARY 11.29.2023</p> <p>11.29.2023 99.61 ft 642 mbar 778 mbar</p>
99.8	<p><b>Joint Offset Medium</b>  <b>Severity: None</b>  <b>Struct Weight: 1</b></p>	16:32

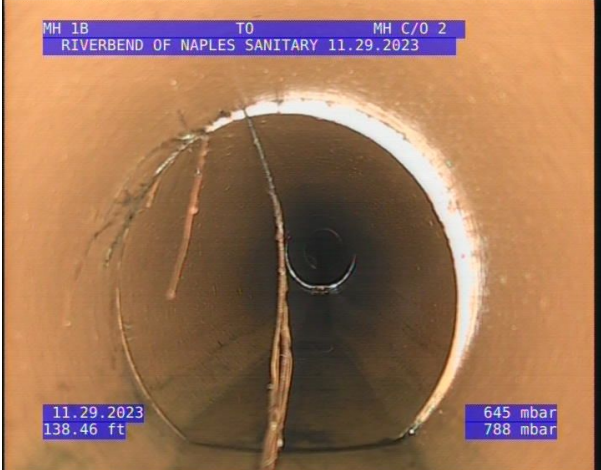
Distance	Fault Observation	Time	Picture
138.5	<p>Roots Fine Joint            Position: 10 To 12            Severity: None            Joint            Maint Weight: 1</p>	21:27

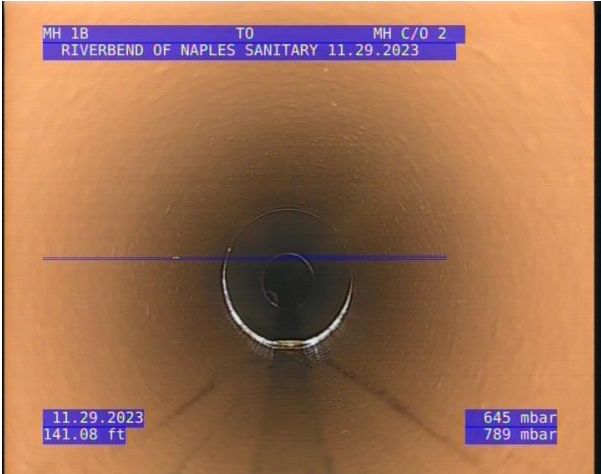
141.0	<p>Water Level Sag            Severity: None            Cont Defect: F02            Percent: 5            Struct Weight: 2</p>	22:06

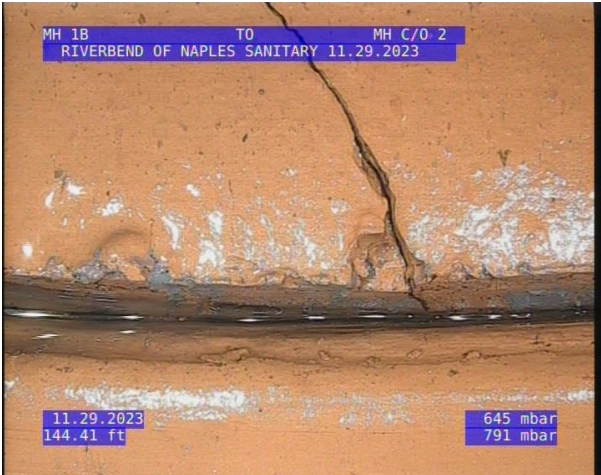
144.4	<p>Infil Dripper            Position: 4            Severity: None            Joint            Maint Weight: 3</p>	23:27

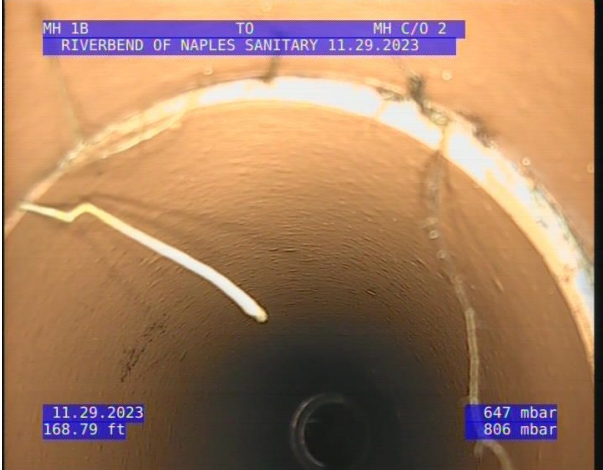
Distance	Fault Observation	Time	Picture
168.8	<p><b>Roots Fine Joint</b>  <b>Position: 10 To 1</b>  <b>Severity: None</b>  <b>Joint</b>  <b>Maint Weight: 1</b></p>	30:47

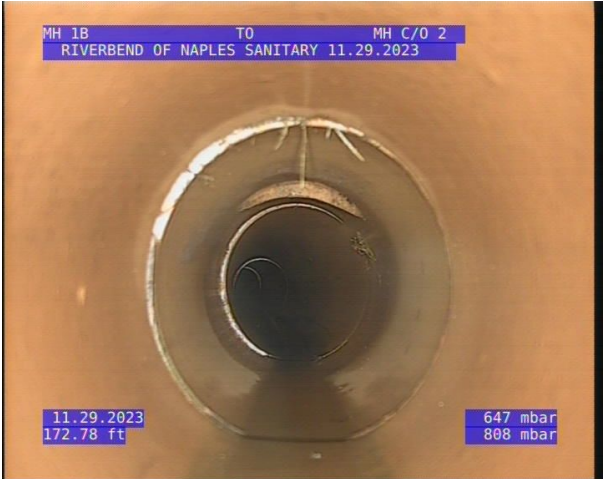
172.8	<p><b>Water Level Sag</b>  <b>Severity: None</b>  <b>Cont Defect: F03</b>  <b>Percent: 5</b>  <b>Struct Weight: 2</b></p>	31:21

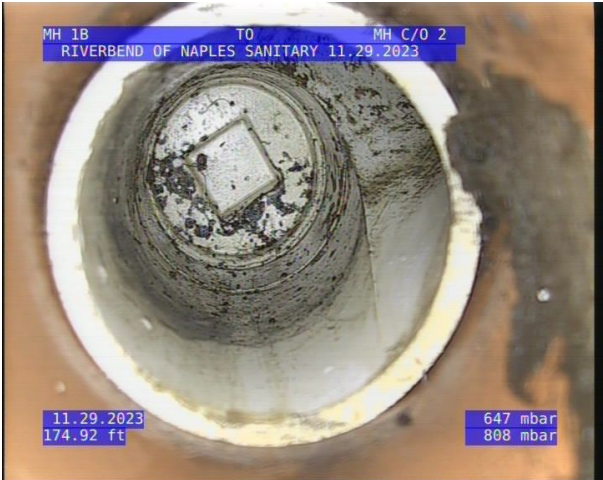
174.9	<p><b>Tap Factory</b>  <b>Position: 12</b>  <b>Severity: None</b>  <b>Size: 6</b></p>	31:47

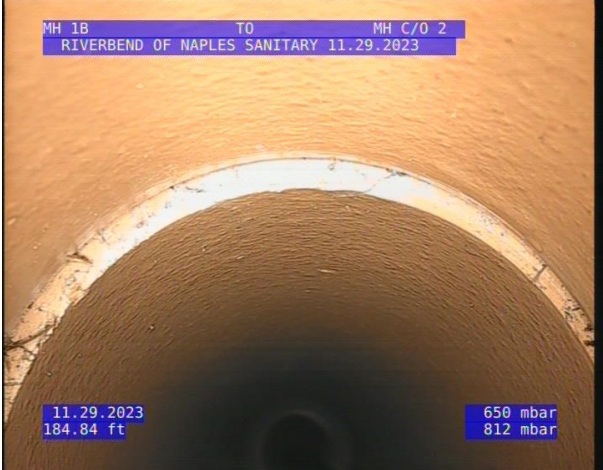
Distance	Fault Observation	Time	Picture
184.8	<b>Joint Offset Medium</b> <b>Severity: None</b> <b>Struct Weight: 1</b>	33:20

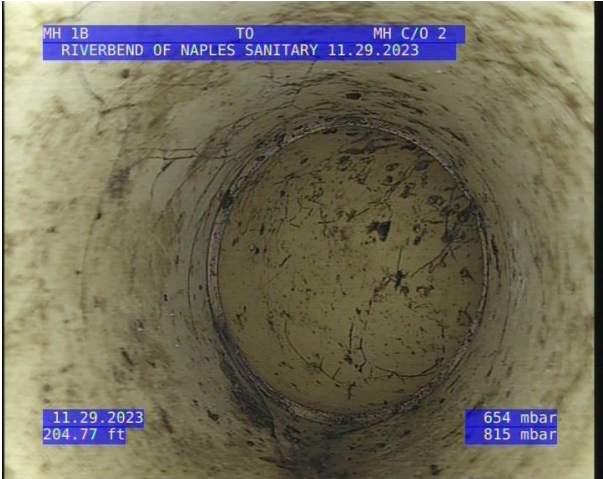
204.8	<b>Tap Factory</b> <b>Position: 12</b> <b>Severity: None</b> <b>Size: 6</b>	35:03

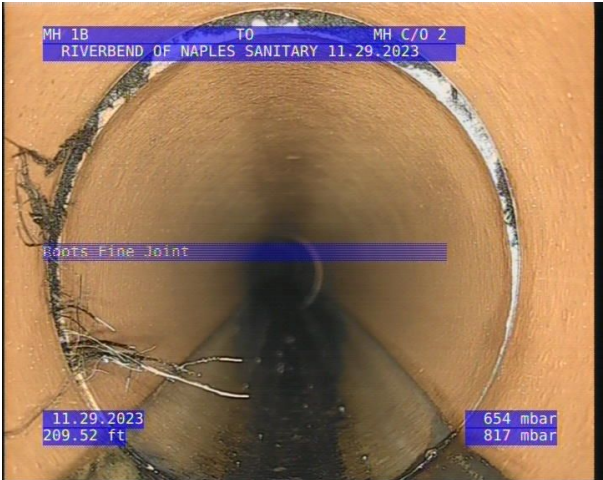
209.5	<b>Roots Fine Joint</b> <b>Position: 7 To 11</b> <b>Severity: None</b> <b>Joint</b> <b>Maint Weight: 1</b>	36:13

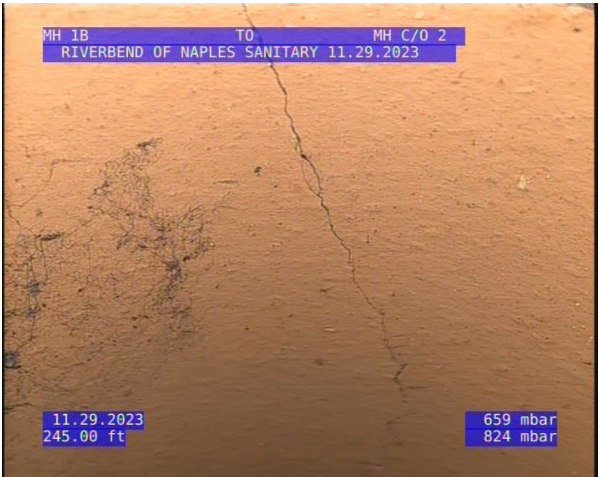
Distance	Fault Observation	Time	Picture
245.0	<p><b>Crack Longitudinal</b>  <b>Position: 2</b>  <b>Severity: None</b>  <b>Struct Weight: 2</b></p>	40:13

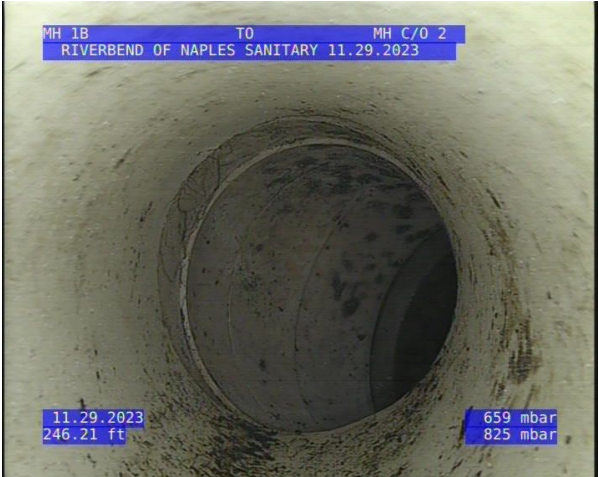
246.2	<p><b>Tap Factory</b>  <b>Position: 12</b>  <b>Severity: None</b>  <b>Size: 6</b></p>	40:34

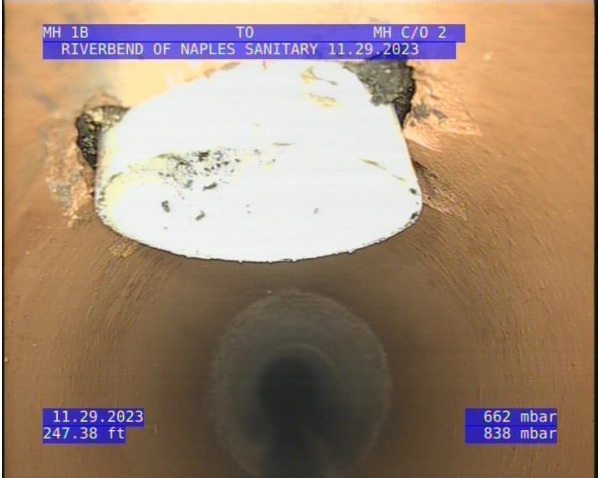
247.4	<p><b>Abandoned Survey</b>  <b>Severity: None</b>  <b>Remarks: CANT GET THROUGH SERVICE</b></p>	47:59
