| <b>Work Order</b> | | <b>Project</b> | RIVERBEND OF NAPLES SANITARY 11.30.2023 |

# Project: RIVERBEND OF NAPLES SANITARY

## 11.30.2023

**Pipe Segment Reference:** MH-3 - MH-4B  
**Upstream MH:** 3  
**Downstream MH:** 4B  
**Direction of Survey:** Downstream  
**Material:** Vitrified Clay Pipe

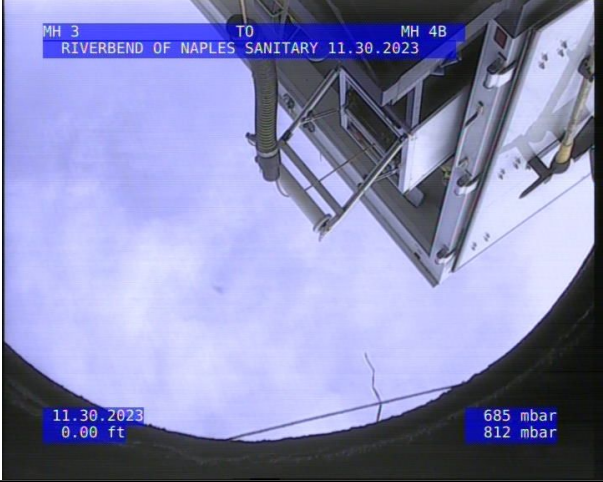
| Distance | Fault Observation | Time | Picture |
|---|--|---|---|
| 0.0 | <b>Manhole</b><br><b>Severity: None</b><br><b>Remarks: 3</b> | 21 | <p> MH 3 TO MH 4B<br/> RIVERBEND OF NAPLES SANITARY 11.30.2023<br/> 11.30.2023 0.00 ft<br/> 685 mbar 812 mbar </p> |

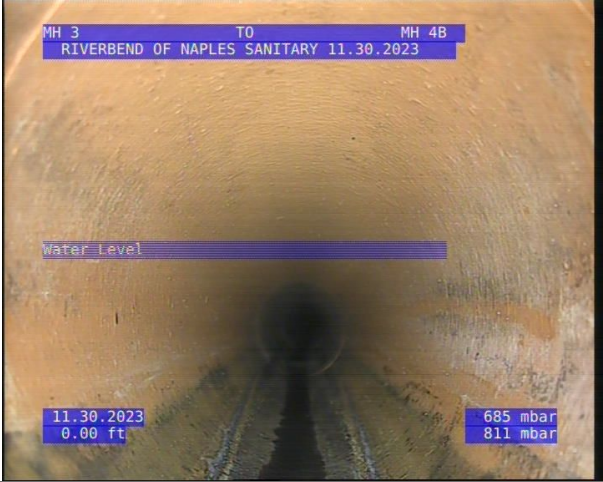
| Distance | Fault Observation | Time | Picture |
|---|--|---|---|
| 0.0 | <b>Water Level</b><br><b>Severity: None</b><br><b>Percent: 5</b> | 30 | <p> MH 3 TO MH 4B<br/> RIVERBEND OF NAPLES SANITARY 11.30.2023<br/> Water Level<br/> 11.30.2023 0.00 ft<br/> 685 mbar 811 mbar </p> |

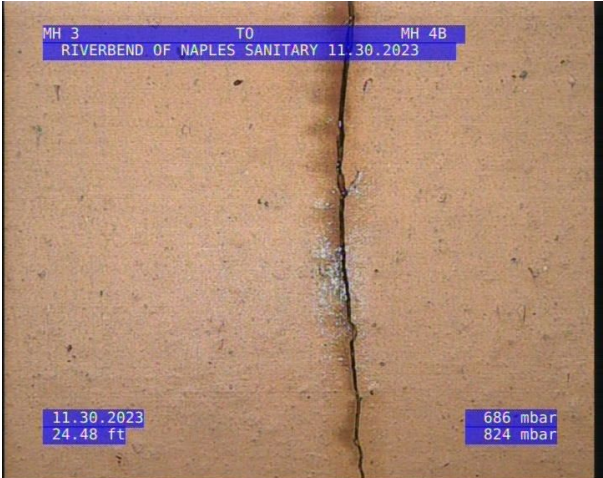
| Distance | Fault Observation | Time | Picture |
|---|--|---|---|
| 0.0 | <b>Crack Longitudinal</b><br><b>Position: 12</b><br><b>Severity: None</b><br><b>Struct Weight: 2</b> | 05:37 | <p> MH 3 TO MH 4B<br/> RIVERBEND OF NAPLES SANITARY 11.30.2023<br/> 11.30.2023 24.48 ft<br/> 686 mbar 824 mbar </p> |

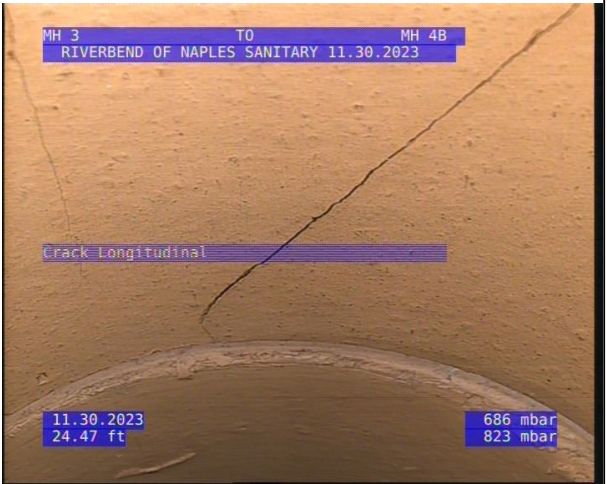
| Distance | Fault Observation | Time | Picture |
|---|---|---|--|
| 24.5 | <p><b>Crack Longitudinal</b><br/> <b>Position: 1</b><br/> <b>Severity: None</b><br/> <b>Struct Weight: 2</b></p> | 05:09 | |

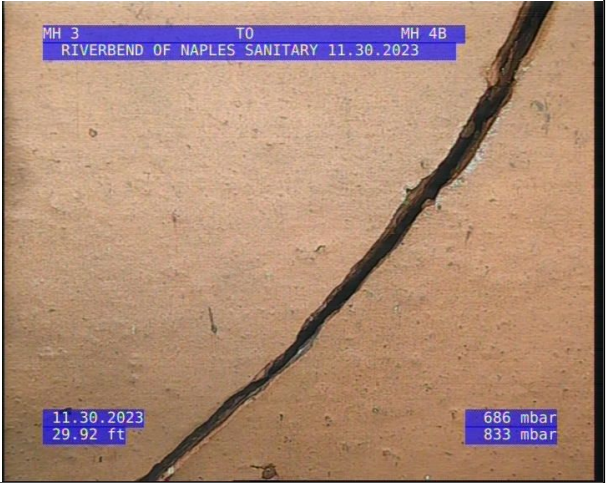
| Distance | Fault Observation | Time | Picture |
|---|---|---|--|
| 29.9 | <p><b>Fracture Circumferential</b><br/> <b>Position: 3 To 9</b><br/> <b>Severity: None</b><br/> <b>Joint</b><br/> <b>Struct Weight: 2</b></p> | 10:06 | |

| Distance | Video Ref | Code | Cont Defect | Value | | | Joint | Circumferential Location | |
|---|---|---|---|---|---|---|---|---|---|
| 29.9 | 606 | FC - Fracture Circumferential | | | | | X | 3 9 | |

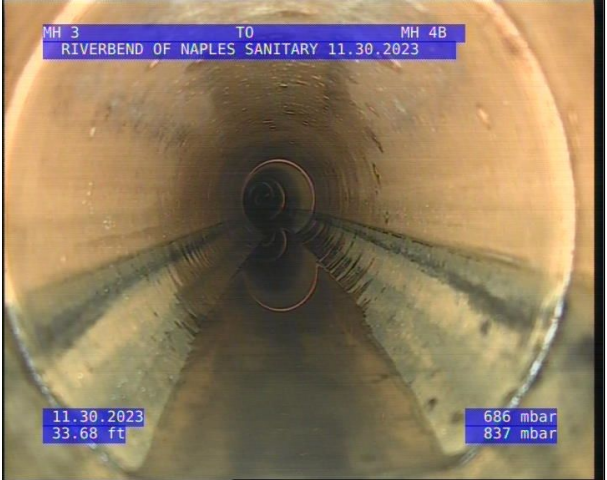
| Distance | Fault Observation | Time | Picture |
|---|---|---|--|
| 33.7 | <p><b>Water Level Sag</b><br/> <b>Severity: None</b><br/> <b>Cont Defect: S01</b><br/> <b>Percent: 5</b><br/> <b>Struct Weight: 2</b></p> | 11:25 | |

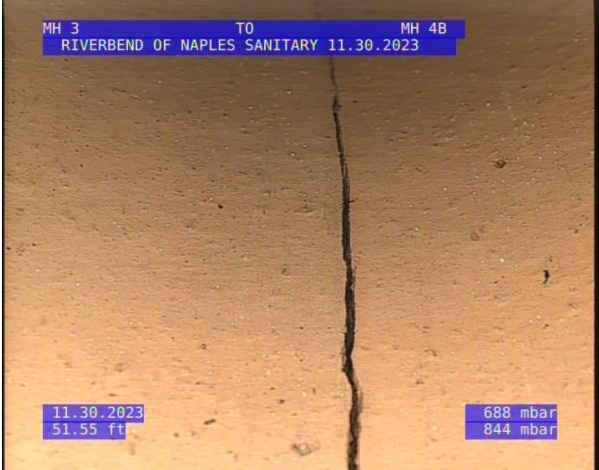
| Distance | Fault Observation | Time | Picture |
|---|--|---|---|
| 51.6 | <p><b>Crack Longitudinal</b><br/> <b>Position: 4</b><br/> <b>Severity: None</b><br/> <b>Struct Weight: 2</b></p> | 15:44 | <p>MH 3 TO MH 4B<br/>RIVERBEND OF NAPLES SANITARY 11.30.2023</p> <p>11.30.2023 51.55 ft</p> <p>688 mbar<br/>844 mbar</p> |

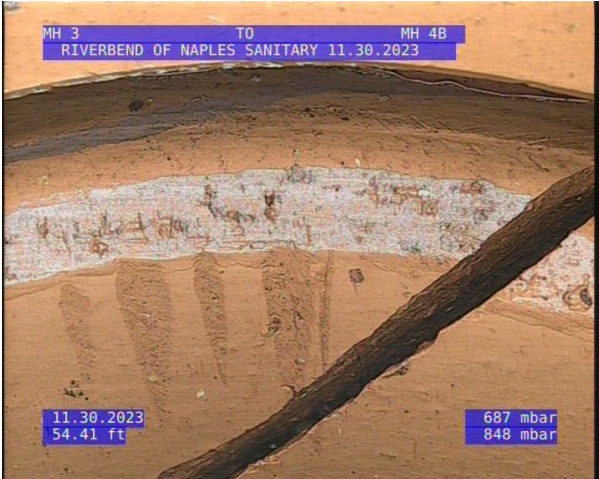
| Distance | Fault Observation | Time | Picture |
|---|--|---|---|
| 54.4 | <p><b>Broken</b><br/> <b>Position: 9 To 12</b><br/> <b>Severity: None</b><br/> <b>Struct Weight: 5</b></p> | 17:36 | <p>MH 3 TO MH 4B<br/>RIVERBEND OF NAPLES SANITARY 11.30.2023</p> <p>11.30.2023 54.41 ft</p> <p>687 mbar<br/>848 mbar</p> |

| Distance | Video Ref | Code | Cont Defect | Value | | | Joint | Circumferential Location | |
|---|---|---|---|---|---|---|---|---|---|
| 54.4 | 1056 | B - Broken | | | | | | 9 12 | |

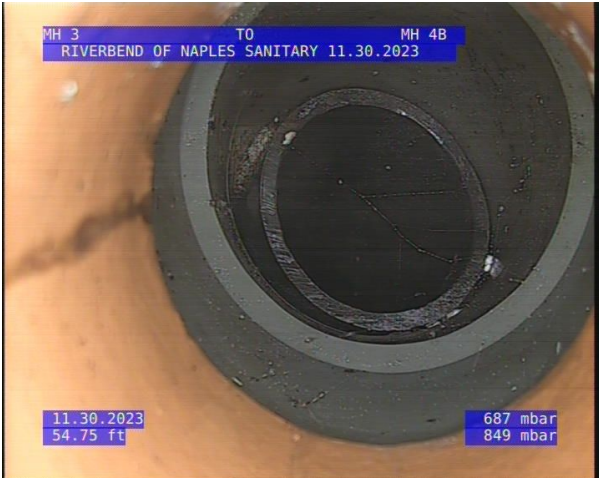
| Distance | Fault Observation | Time | Picture |
|---|--|---|---|
| 54.8 | <p><b>Tap Factory</b><br/> <b>Position: 10</b><br/> <b>Severity: None</b><br/> <b>Size: 6</b></p> | 18:09 | <p>MH 3 TO MH 4B<br/>RIVERBEND OF NAPLES SANITARY 11.30.2023</p> <p>11.30.2023 54.75 ft</p> <p>687 mbar<br/>849 mbar</p> |

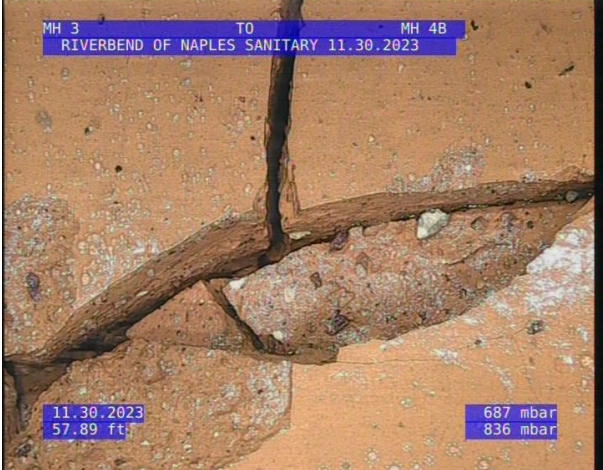
| Distance | Fault Observation | Time | Picture |
|---|--|---|--|
| 57.9 | <p align="center"><b>Broken</b><br/> <b>Position: 12 To 12</b><br/> <b>Severity: None</b><br/> <b>Struct Weight: 5</b></p> | 20:46 | |

| Distance | Video Ref | Code | Cont Defect | Value | | | Joint | Circumferential Location | |
|---|---|---|---|---|---|---|---|---|---|
| 57.9 | 1246 | B - Broken | | | | | | 12 12 | |

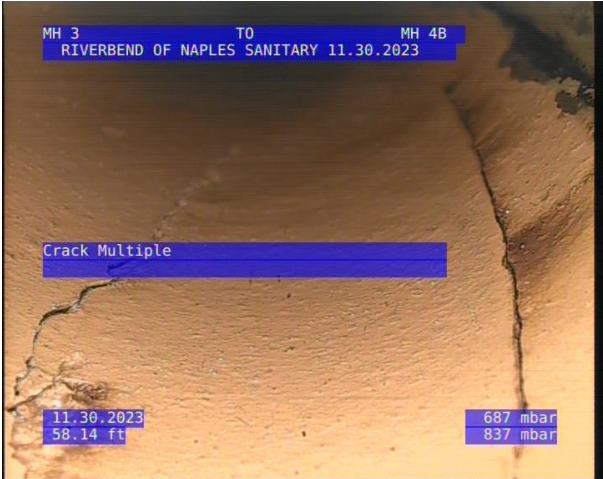
| Distance | Fault Observation | Time | Picture |
|---|--|---|--|
| 58.1 | <p align="center"><b>Crack Multiple</b><br/> <b>Position: 7 To 9</b><br/> <b>Severity: None</b><br/> <b>Struct Weight: 3</b></p> | 21:32 | |

| Distance | Video Ref | Code | Cont Defect | Value | | | Joint | Circumferential Location | |
|---|---|---|---|---|---|---|---|---|---|
| 58.1 | 1292 | CM - Crack Multiple | | | | | | 7 9 | |

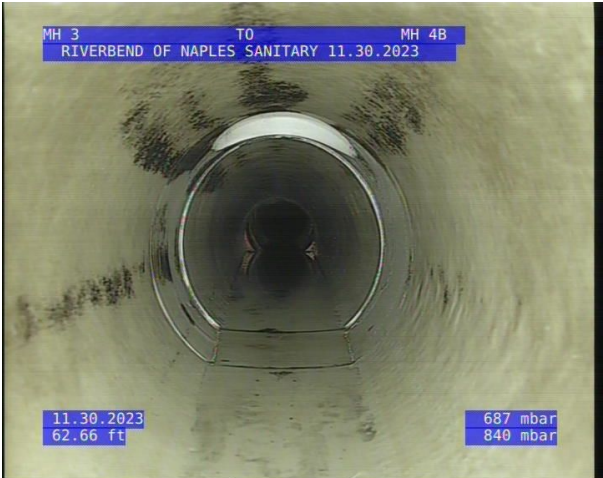
| Distance | Fault Observation | Time | Picture |
|---|--|---|--|
| 62.7 | <p align="center"><b>Material Change</b><br/> <b>Severity: None</b><br/> <b>Remarks: PVC</b></p> | 23:14 | |

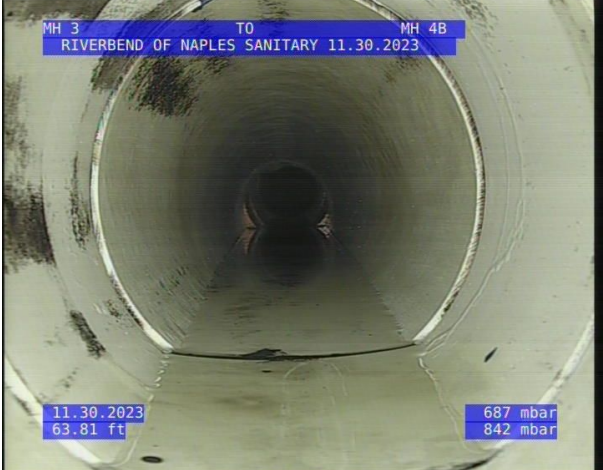
| Distance | Fault Observation | Time | Picture |
|---|--|---|--|
| 63.8 | <p><b>Water Level Sag</b><br/> <b>Severity: None</b><br/> <b>Cont Defect: S02</b><br/> <b>Percent: 10</b><br/> <b>Struct Weight: 2</b></p> | 23:41 | |

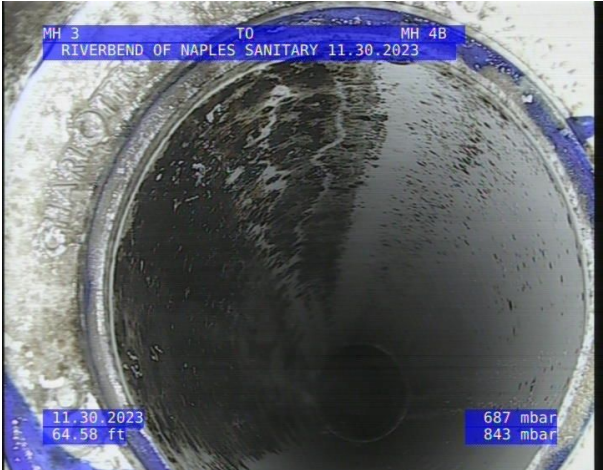
| Distance | Fault Observation | Time | Picture |
|---|--|---|--|
| 64.6 | <p><b>Tap Factory</b><br/> <b>Position: 12</b><br/> <b>Severity: None</b><br/> <b>Size: 6</b></p> | 24:12 | |

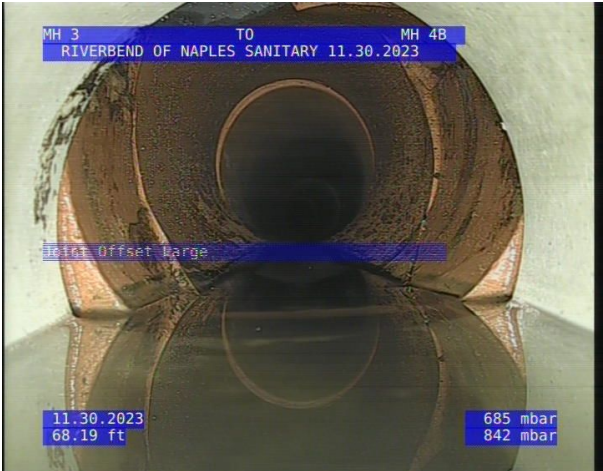
| Distance | Fault Observation | Time | Picture |
|---|--|---|--|
| 68.2 | <p><b>Joint Offset Large</b><br/> <b>Severity: None</b><br/> <b>Struct Weight: 2</b></p> | 25:11 | |

| 68.2 | 1511 | JOL - Joint Offset Large | | | | | | |

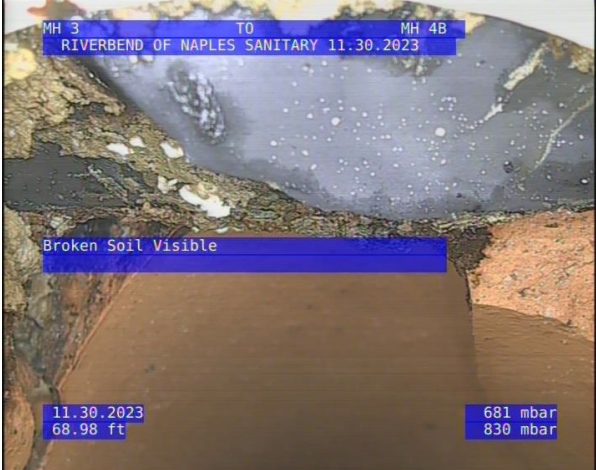
| Distance | Fault Observation | Time | Picture |
|---|--|---|--|
| 69.0 | <p><b>Broken Soil Visible</b><br/> <b>Position: 12 To 11</b><br/> <b>Severity: None</b><br/> <b>Struct Weight: 5</b></p> | 26:24 | |

| 69 | 1584 | BSV - Broken Soil Visible | | | | | 12 | 11 |

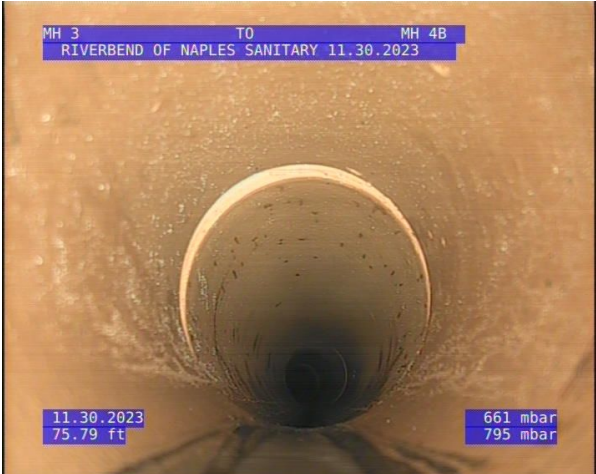
| Distance | Fault Observation | Time | Picture |
|---|--|---|--|
| 75.8 | <p><b>Material Change</b><br/> <b>Severity: None</b><br/> <b>Remarks: VCP</b></p> | 29:49 | |

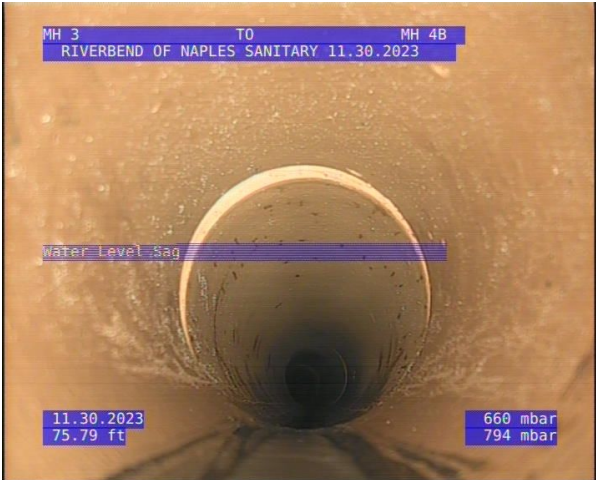
| Distance | Fault Observation | Time | Picture |
|---|--|---|--|
| 75.8 | <p><b>Water Level Sag</b><br/> <b>Severity: None</b><br/> <b>Cont Defect: F02</b><br/> <b>Percent: 10</b><br/> <b>Struct Weight: 2</b></p> | 30:00 | |

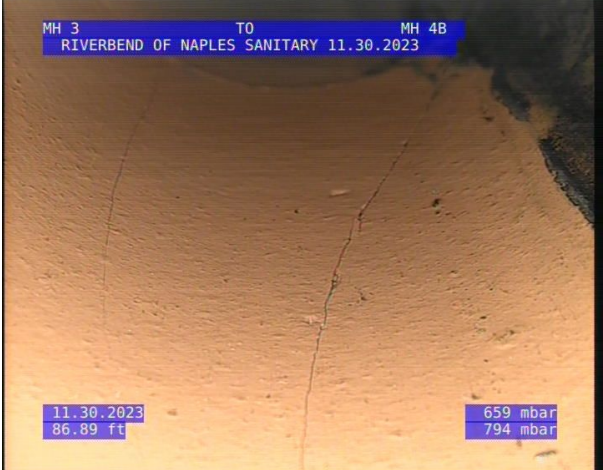
| Distance | Fault Observation | Time | Picture |
|---|--|---|--|
| 86.9 | <p><b>Crack Longitudinal</b><br/> <b>Position: 8</b><br/> <b>Severity: None</b><br/> <b>Struct Weight: 2</b></p> | 31:16 | |

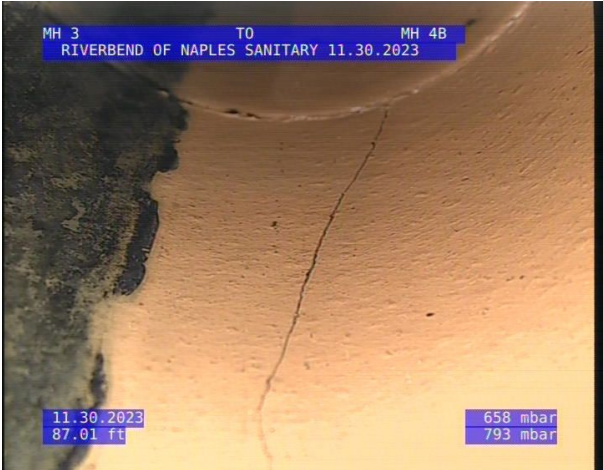
| Distance | Fault Observation | Time | Picture |
|---|--|---|--|
| 87.0 | <p><b>Crack Longitudinal</b><br/> <b>Position: 5</b><br/> <b>Severity: None</b><br/> <b>Struct Weight: 2</b></p> | 31:53 | |

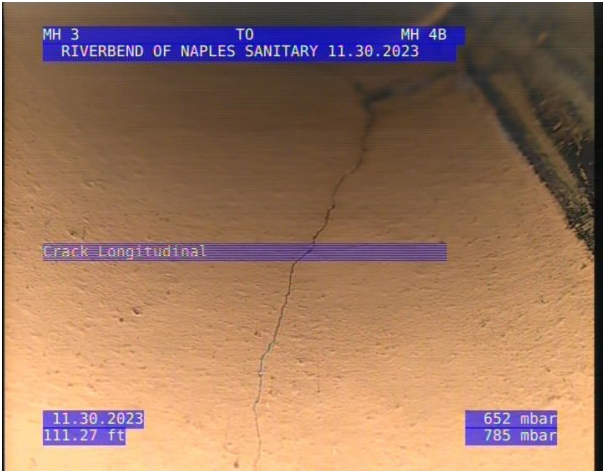
| Distance | Fault Observation | Time | Picture |
|---|--|---|--|
| 111.3 | <p><b>Crack Longitudinal</b><br/> <b>Position: 8</b><br/> <b>Severity: None</b><br/> <b>Struct Weight: 2</b></p> | 35:01 | |

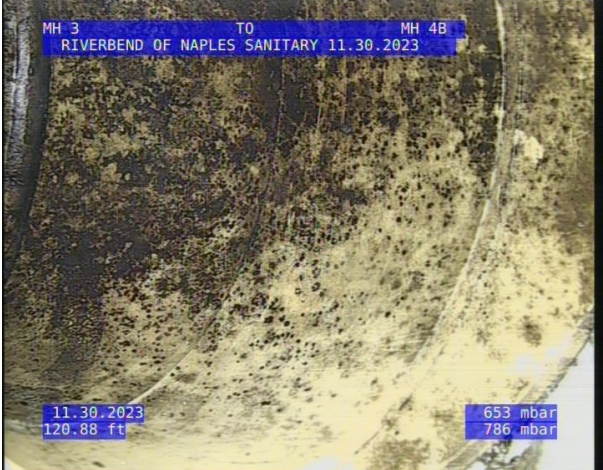
| Distance | Fault Observation | Time | Picture |
|---|--|---|--|
| 120.9 | <p style="text-align: center;"><b>Tap Factory<br/>Position: 12<br/>Severity: None<br/>Size: 6</b></p> | 35:48 | |

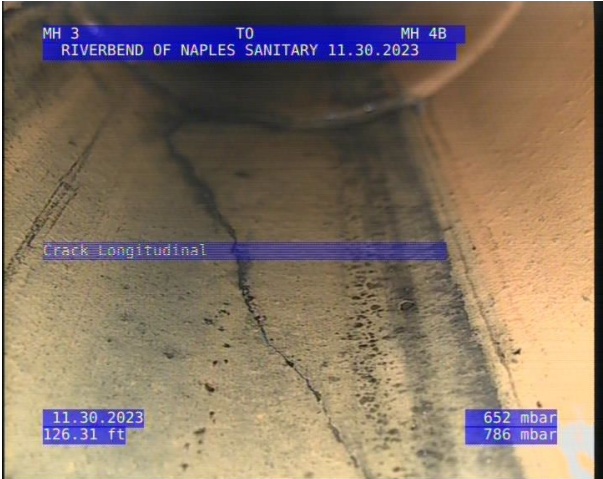
| Distance | Fault Observation | Time | Picture |
|---|--|---|--|
| 126.3 | <p style="text-align: center;"><b>Crack Longitudinal<br/>Position: 5<br/>Severity: None<br/>Struct Weight: 2</b></p> | 37:15 | |

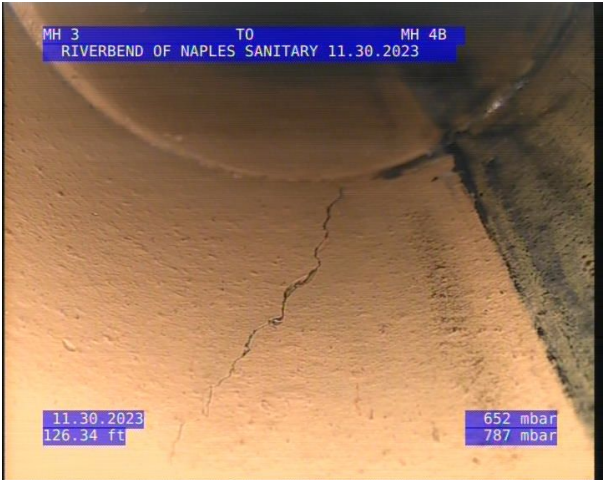
| Distance | Fault Observation | Time | Picture |
|---|--|---|--|
| 126.3 | <p style="text-align: center;"><b>Crack Longitudinal<br/>Position: 8<br/>Severity: None<br/>Struct Weight: 2</b></p> | 37:41 | |

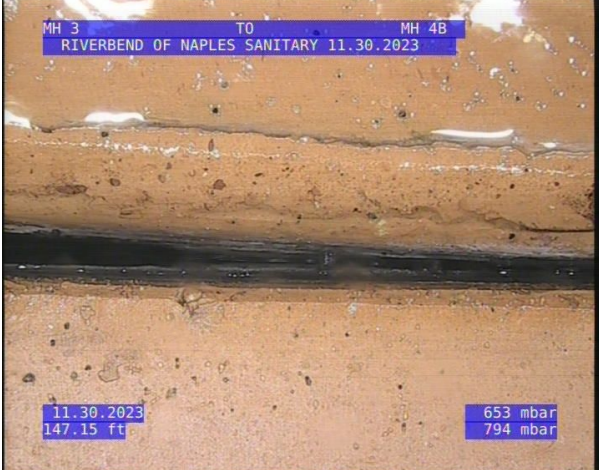
| Distance | Fault Observation | Time | Picture |
|---|---|---|--|
| 147.1 | <p style="text-align: center;"> <b>Infil Dripper</b><br/> <b>Position: 3</b><br/> <b>Severity: None</b><br/> <b>Joint</b><br/> <b>Maint Weight: 3</b> </p> | 44:30 | |

| 147.1 | 2670 | ID - Infil Dripper | | | | | X | 3 |

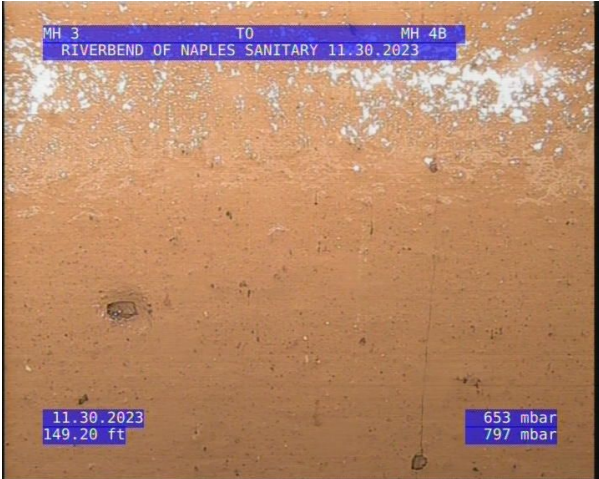
| Distance | Fault Observation | Time | Picture |
|---|---|---|--|
| 149.2 | <p style="text-align: center;"> <b>Crack Spiral</b><br/> <b>Position: 9 To 3</b><br/> <b>Severity: None</b><br/> <b>Cont Defect: F03</b><br/> <b>Struct Weight: 2</b> </p> | 45:53 | |

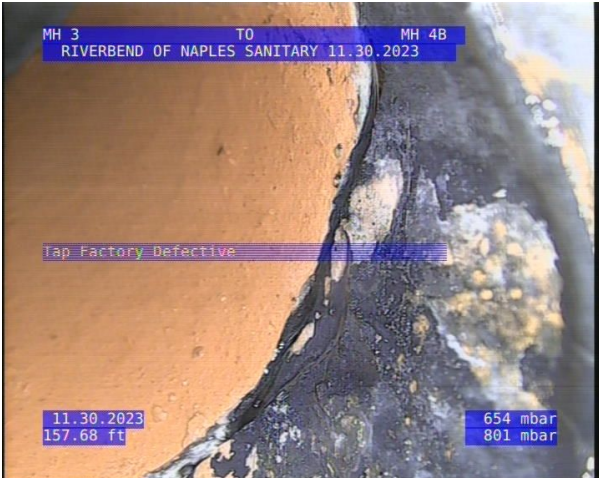
| Distance | Fault Observation | Time | Picture |
|---|---|---|--|
| 157.7 | <p style="text-align: center;"> <b>Tap Factory Defective</b><br/> <b>Position: 12</b><br/> <b>Severity: None</b><br/> <b>Size: 4</b><br/> <b>Remarks: CRACK AT</b><br/> <b>SERVICE AND INFIL</b><br/> <b>DRIPPER</b><br/> <b>Maint Weight: 2</b> </p> | 48:12 | |

| 157.7 | 2892 | TFD - Tap Factory Defective | | 4 | | | | 12 |
| | | CRACK AT SERVICE AND INFIL DRIPPER | | | | | | |

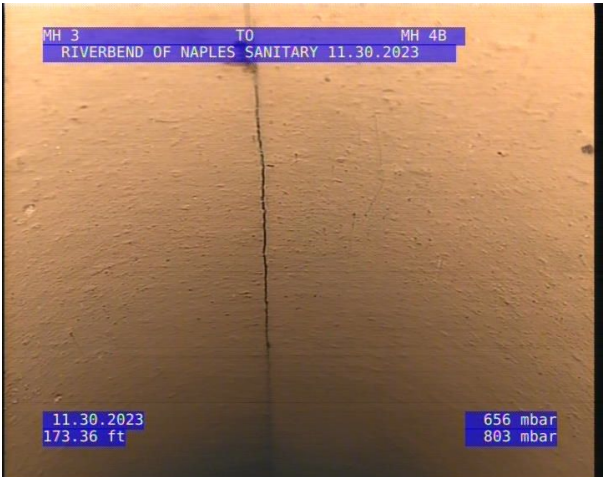
| Distance | Fault Observation | Time | Picture |
|---|---|---|--|
| 173.4 | <p><b>Crack Longitudinal</b><br/> <b>Position: 10</b><br/> <b>Severity: None</b><br/> <b>Struct Weight: 2</b></p> | 49:26 | |

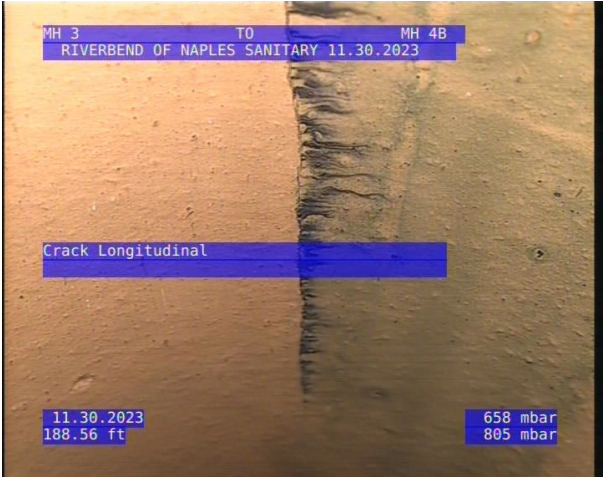
| Distance | Fault Observation | Time | Picture |
|---|---|---|--|
| 188.6 | <p><b>Crack Longitudinal</b><br/> <b>Position: 3</b><br/> <b>Severity: None</b><br/> <b>Struct Weight: 2</b></p> | 50:56 | |

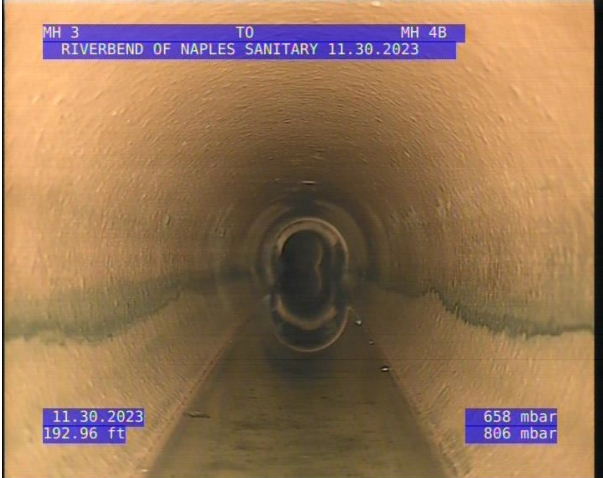
| Distance | Fault Observation | Time | Picture |
|---|---|---|--|
| 193.0 | <p><b>Water Level Sag</b><br/> <b>Severity: None</b><br/> <b>Percent: 10</b><br/> <b>Struct Weight: 2</b></p> | 51:31 | |

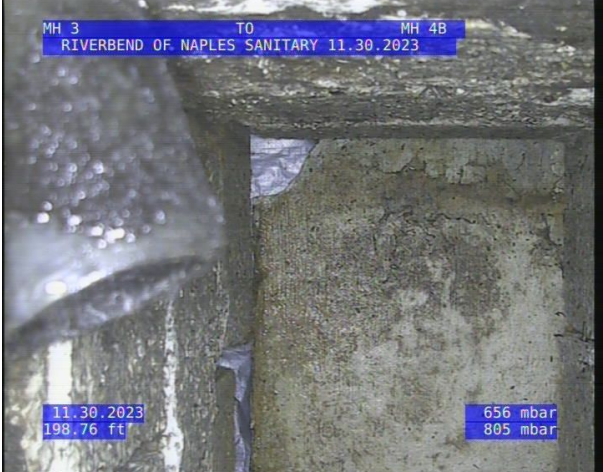
| Distance | Fault Observation | Time | Picture |
|---|--|---|---|
| 198.8 | <p style="text-align: center;"><b>Manhole</b><br/> <b>Severity: None</b><br/> <b>Remarks: 4B</b></p> | 53:55 | |
