Project: RIVERBEND OF NAPLES SANITARY

11.30.2023

Pipe Segment Reference: MH-3 - C/O-3
Upstream MH: C/O 3
Downstream MH: 3
Direction of Survey: Upstream
Material: Vitrified Clay Pipe

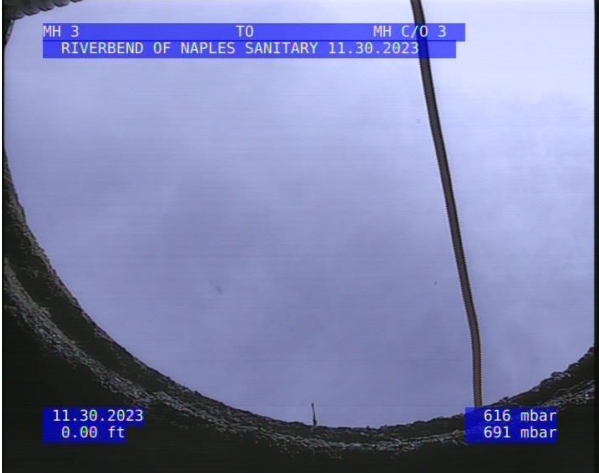
Distance	Fault Observation	Time	Picture
0.0	<p style="text-align: center;"> Manhole Severity: None Remarks: 3 </p>	15

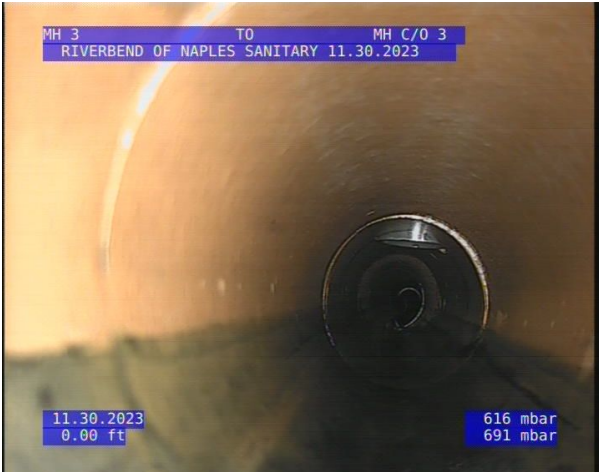
0.0	<p style="text-align: center;"> Water Level Severity: None Percent: 5 </p>	26

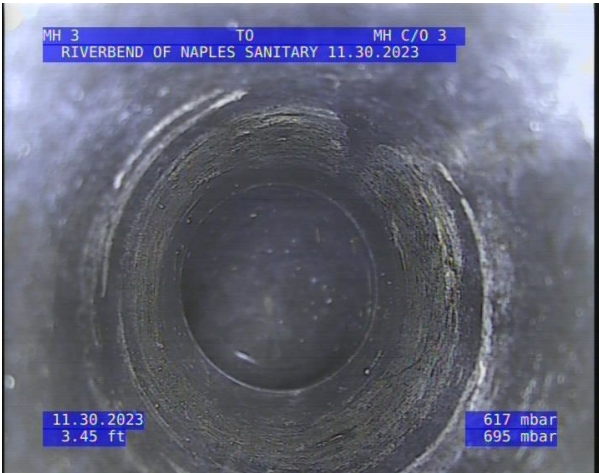
3.5	<p style="text-align: center;"> Tap Factory Position: 12 Severity: None Size: 6 </p>	01:25

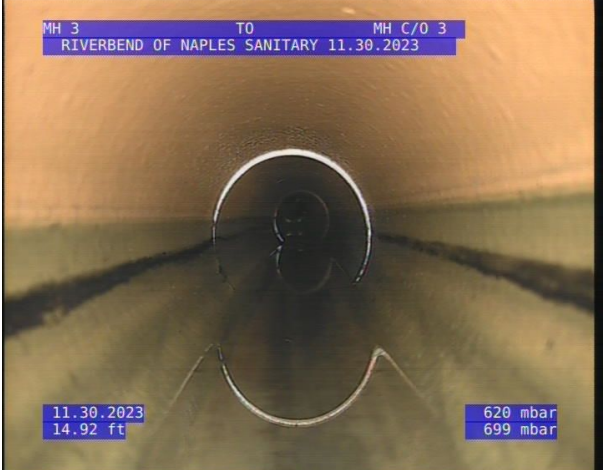
Distance	Fault Observation	Time	Picture
14.9	<p>Water Level Sag Severity: None Cont Defect: S01 Percent: 10 Struct Weight: 2</p>	02:27

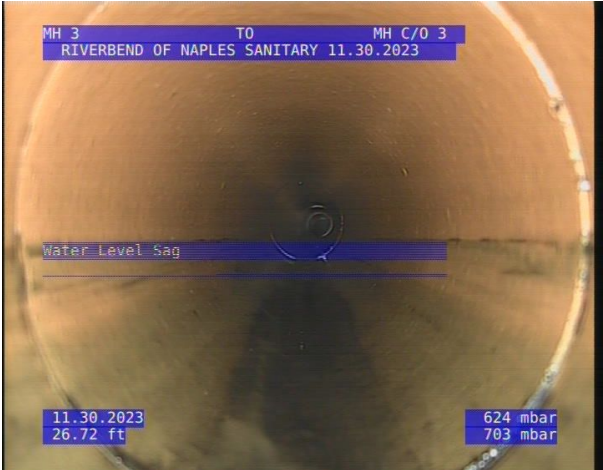
26.7	<p>Water Level Sag Severity: None Cont Defect: F01 Percent: 10 Struct Weight: 2</p>	03:33

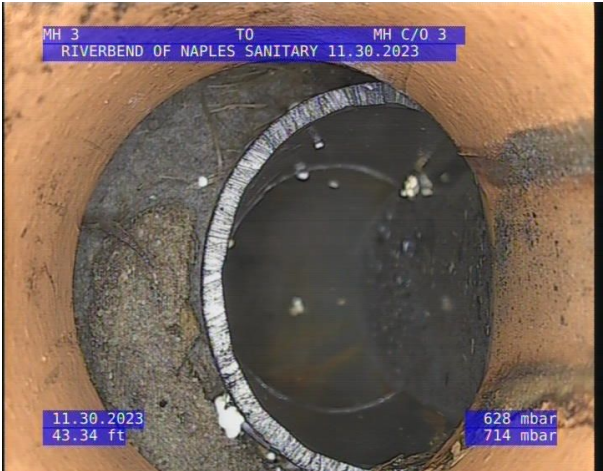
43.3	<p>Tap Factory Defective Position: 3 Severity: None Size: 4 Remarks: PIPE OFF SET Maint Weight: 2</p>	06:56

(43.3) TFD - Tap Factory Defective - Position: 3
Remark: PIPE OFF SET

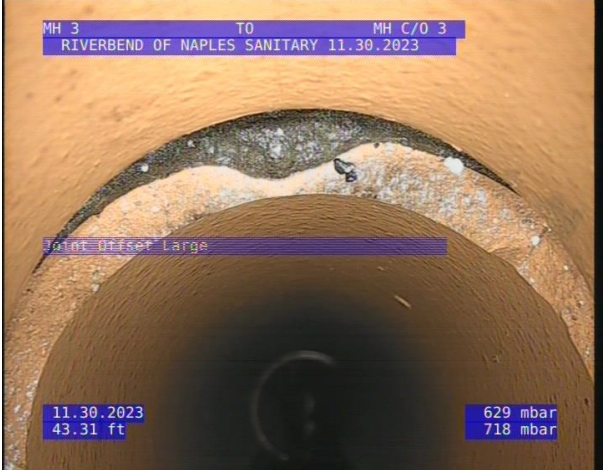
Distance	Fault Observation	Time	Picture
43.3	<p>Joint Offset Large Severity: None Struct Weight: 2</p>	08:08

(43.3) JOL - Joint Offset Large

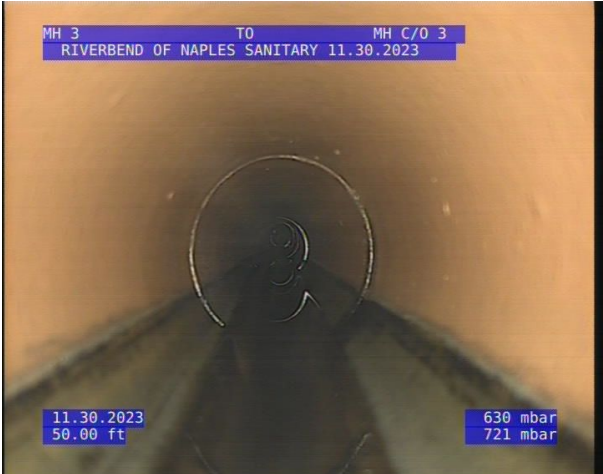
50.0	<p>Water Level Sag Severity: None Cont Defect: S02 Percent: 10 Struct Weight: 2</p>	08:58

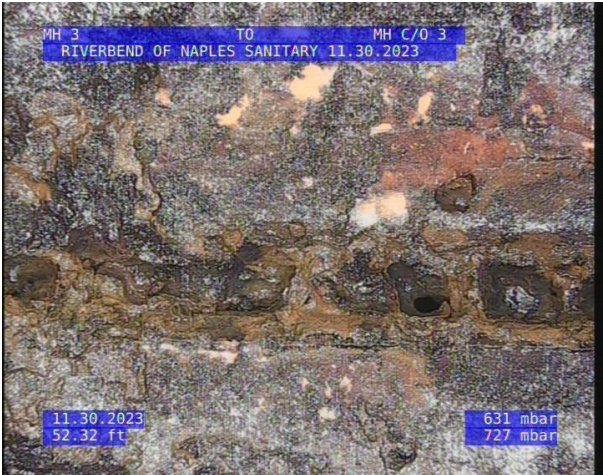
52.3	<p>Infil Stain Position: 9 To 4 Severity: None Joint</p>	10:56

(52.3) IS - Infil Stain - Position: 9 To 4

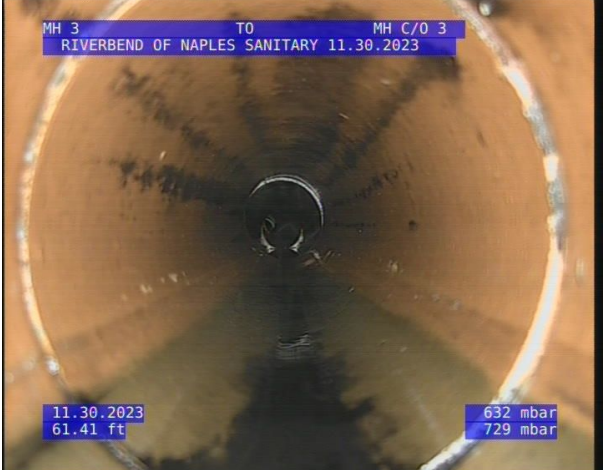
Distance	Fault Observation	Time	Picture
61.4	<p>Water Level Sag Severity: None Cont Defect: F02 Percent: 10 Struct Weight: 2</p>	11:44

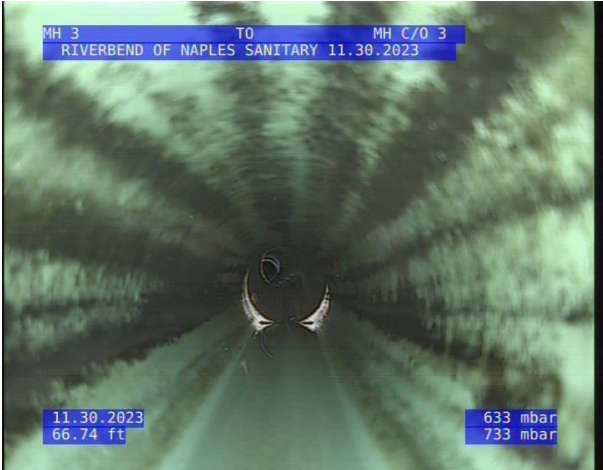
66.7	<p>Material Change Severity: None Remarks: PVC</p>	13:09

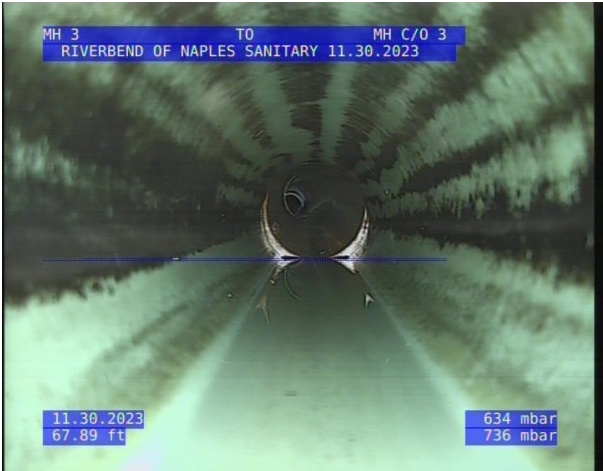
67.9	<p>Water Level Sag Severity: None Cont Defect: S03 Percent: 5 Struct Weight: 2</p>	13:55

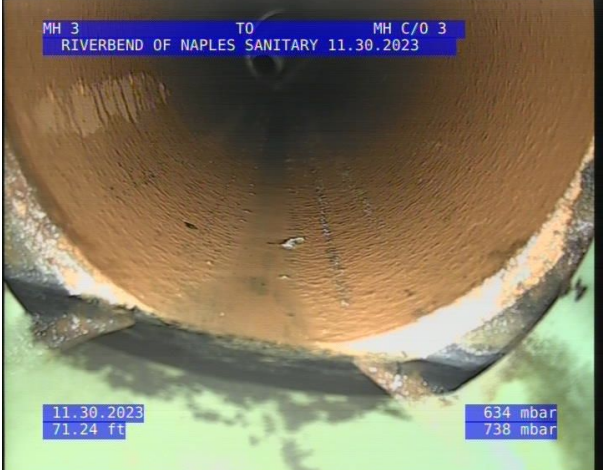
Distance	Fault Observation	Time	Picture
71.2	Joint Offset Medium Severity: None Struct Weight: 1	14:45

(71.2) JOM - Joint Offset Medium

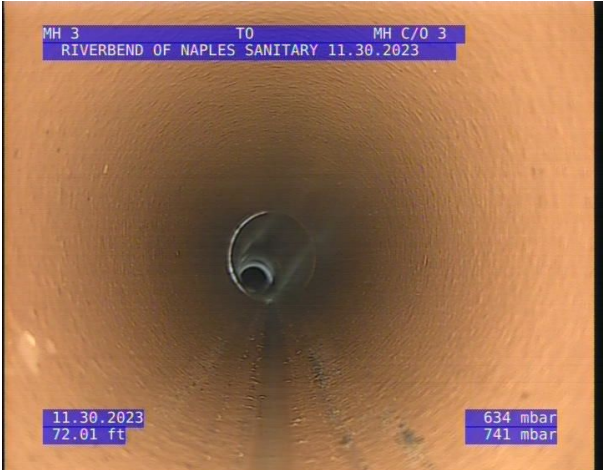
72.0	Material Change Severity: None Remarks: VCP	15:44

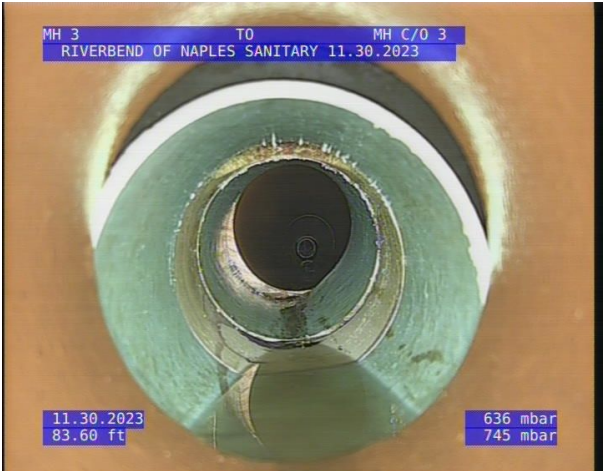
83.6	Joint Offset Large Severity: None Struct Weight: 2	16:58

(83.6) JOL - Joint Offset Large

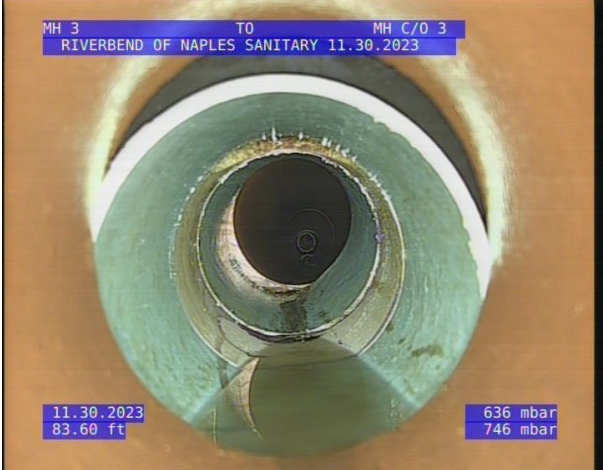
Distance	Fault Observation	Time	Picture
83.6	<p>Water Level Sag Severity: None Cont Defect: F03 Percent: 5 Struct Weight: 2</p>	17:16

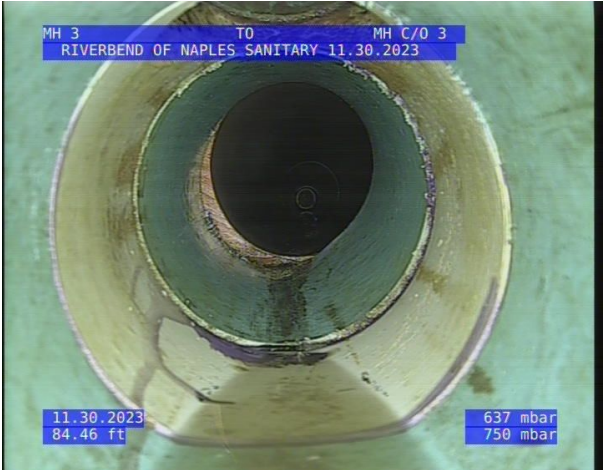
84.5	<p>Material Change Severity: None Remarks: PVC</p>	18:27

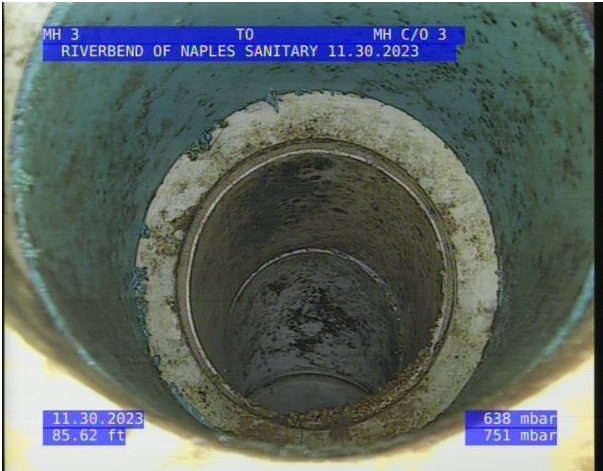
85.6	<p>Tap Factory Position: 12 Severity: None Size: 6</p>	19:01

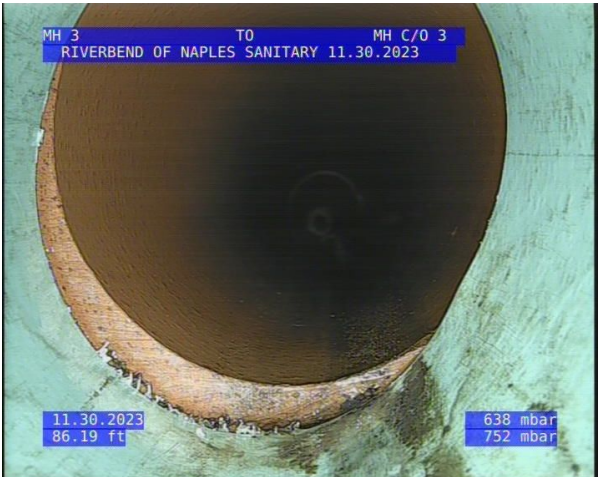
Distance	Fault Observation	Time	Picture
86.2	Joint Offset Medium Severity: None Struct Weight: 1	19:28

(86.2) JOM - Joint Offset Medium

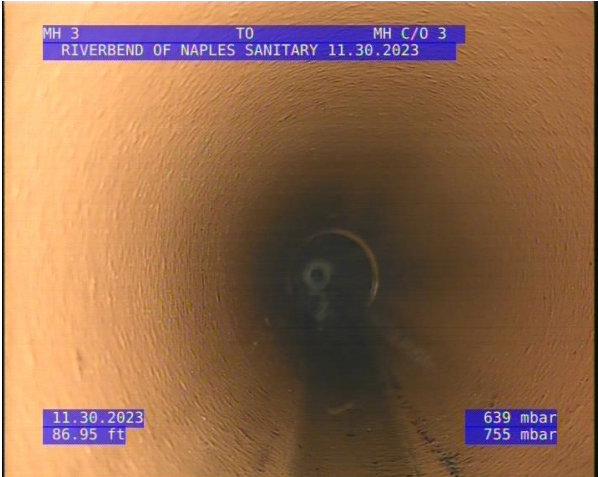
86.9	Material Change Severity: None Remarks: VCP	20:21

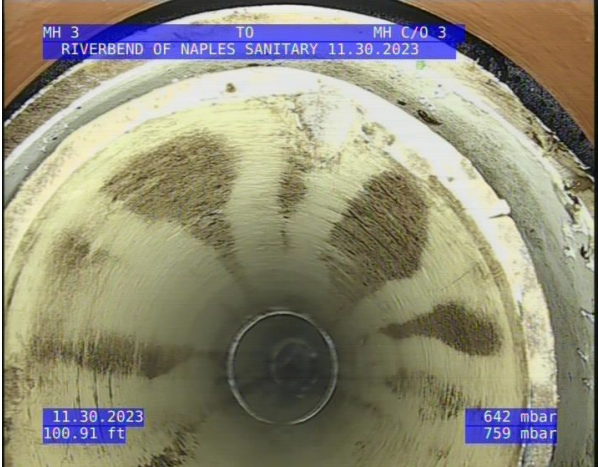
100.9	End of Pipe Severity: None Remarks: CLEAN OUT 3	22:00

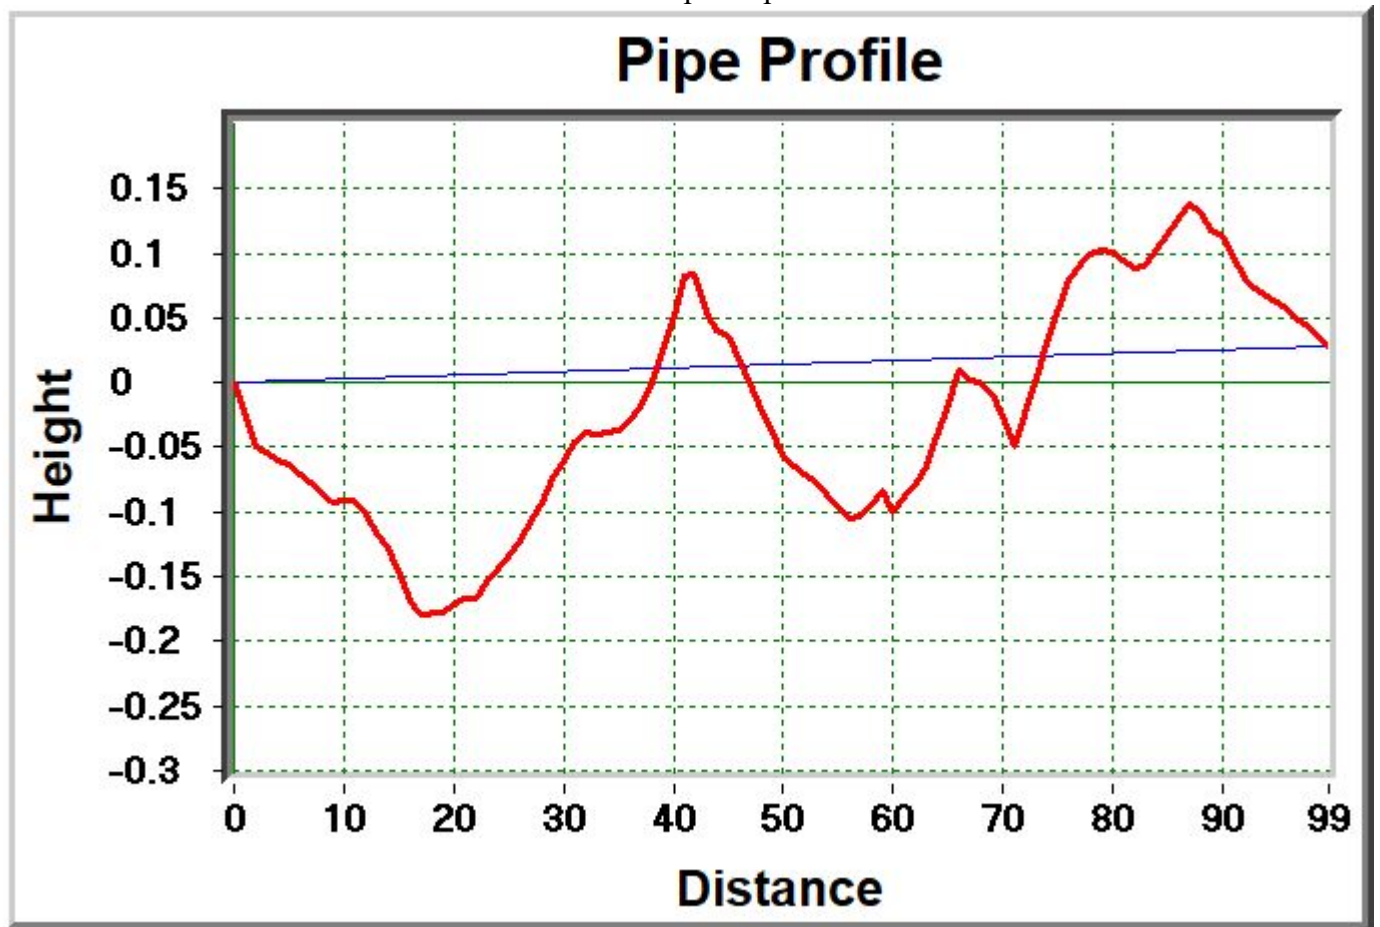
Percent Grade Mean: 0.03
Plot Distance From: 0 To 102
Max Percent Difference: 3
Number of Window Values: 1
Percent Difference Max for Windows Values: 60
Number of Feet to Average: 1
Final number of points plotted: 92
