| <b>Work Order</b> | | <b>Project</b> | RIVERBEND OF NAPLES SANITARY 11.30.2023 |

# Project: RIVERBEND OF NAPLES SANITARY

## 11.30.2023

Pipe Segment Reference: MH-4 - MH-1

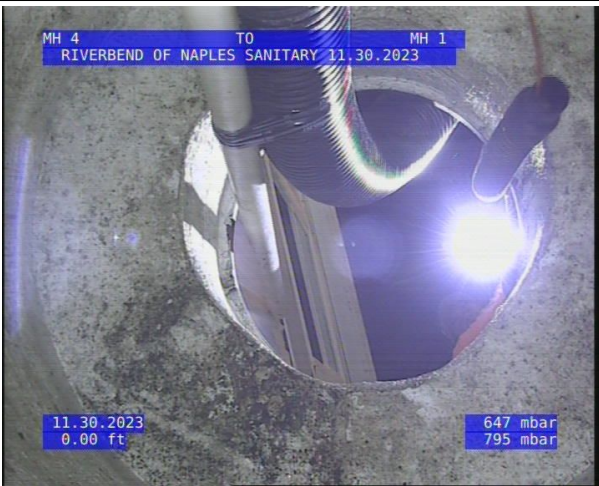
| Distance | Fault Observation | Time | Picture |
|---|---|---|---|
| 0.0 | <b>Manhole</b><br>Severity: None<br>Remarks: 4 | 27 | <p>MH 4 TO MH 1<br/>RIVERBEND OF NAPLES SANITARY 11.30.2023</p> <p>11.30.2023 0.00 ft</p> <p>647 mbar<br/>795 mbar</p> |

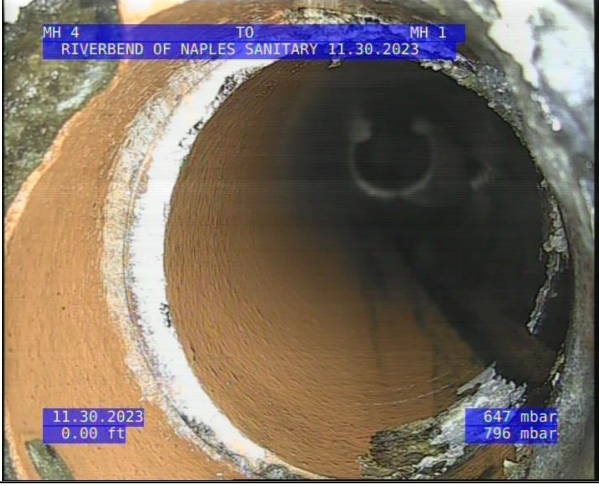
| Distance | Fault Observation | Time | Picture |
|---|---|---|---|
| 0.0 | <b>Water Level</b><br>Severity: None<br>Percent: 5 | 57 | <p>MH 4 TO MH 1<br/>RIVERBEND OF NAPLES SANITARY 11.30.2023</p> <p>11.30.2023 0.00 ft</p> <p>647 mbar<br/>796 mbar</p> |

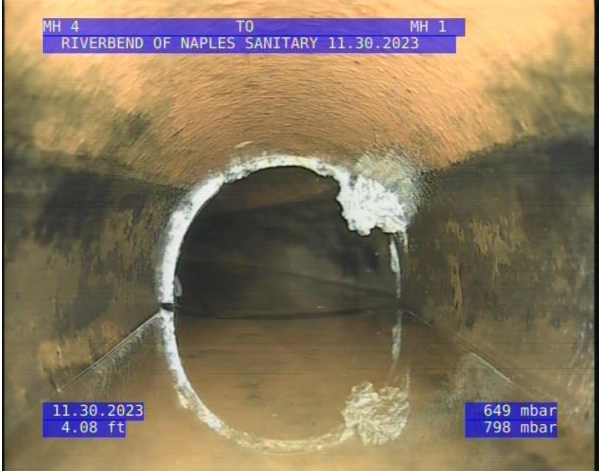
| Distance | Fault Observation | Time | Picture |
|---|---|---|---|
| 4.1 | <b>Water Level Sag</b><br>Severity: None<br>Cont Defect: S01<br>Percent: 10<br>Struct Weight: 2 | 01:55 | <p>MH 4 TO MH 1<br/>RIVERBEND OF NAPLES SANITARY 11.30.2023</p> <p>11.30.2023 4.08 ft</p> <p>649 mbar<br/>798 mbar</p> |

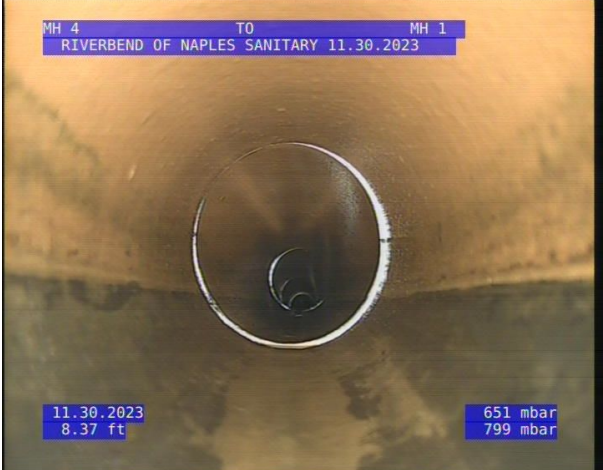
| Distance | Fault Observation | Time | Picture |
|---|--|---|--|
| 8.4 | <p><b>Water Level Sag</b><br/> <b>Severity: None</b><br/> <b>Cont Defect: F01</b><br/> <b>Percent: 10</b><br/> <b>Struct Weight: 2</b></p> | 03:15 | |

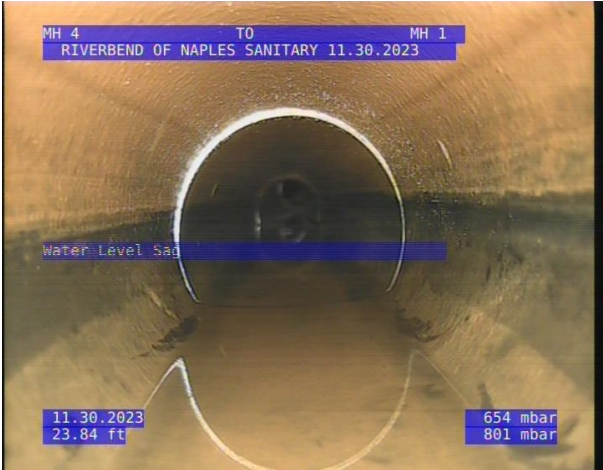
| Distance | Fault Observation | Time | Picture |
|---|--|---|--|
| 23.8 | <p><b>Water Level Sag</b><br/> <b>Severity: None</b><br/> <b>Cont Defect: S02</b><br/> <b>Percent: 5</b><br/> <b>Struct Weight: 2</b></p> | 04:17 | |

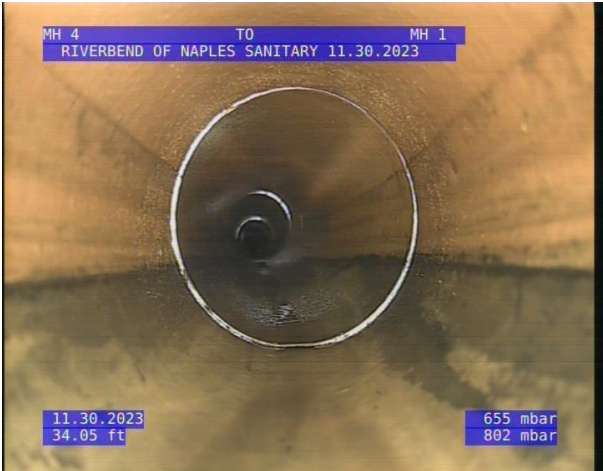
| Distance | Fault Observation | Time | Picture |
|---|--|---|--|
| 34.0 | <p><b>Water Level Sag</b><br/> <b>Severity: None</b><br/> <b>Cont Defect: F02</b><br/> <b>Percent: 5</b><br/> <b>Struct Weight: 2</b></p> | 05:15 | |

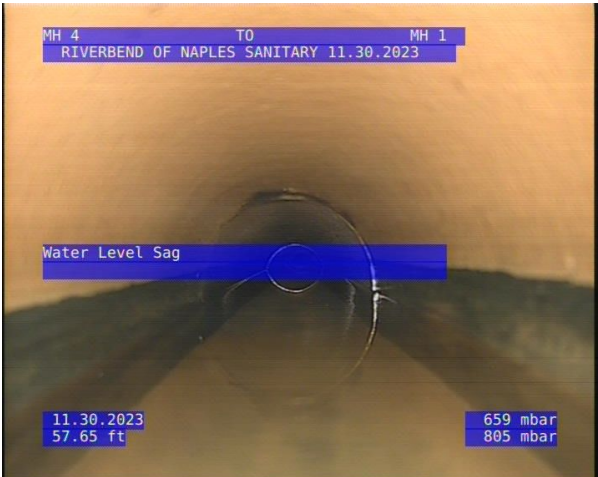
| Distance | Fault Observation | Time | Picture |
|---|---|---|--|
| 57.7 | <b>Water Level Sag</b><br><b>Severity: None</b><br><b>Cont Defect: S03</b><br><b>Percent: 10</b><br><b>Struct Weight: 2</b> | 07:02 | |
