Project: RIVERBEND OF NAPLES SANITARY

Date: 11/30/2023 4:45:00 PM

Pacp Quick Overall Rating: 4222

Pipe Segment Reference: MH-4 - MH-4B

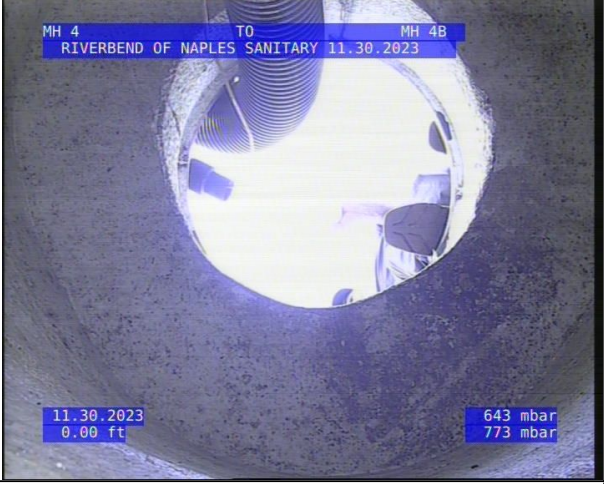
Distance	Fault Observation	Time	Picture
0.0	Manhole Severity: None Remarks: 4	22

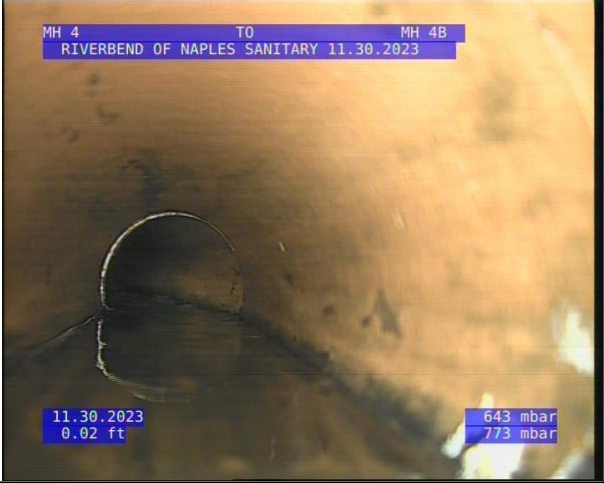
0.0	Water Level Severity: None Percent: 5	45

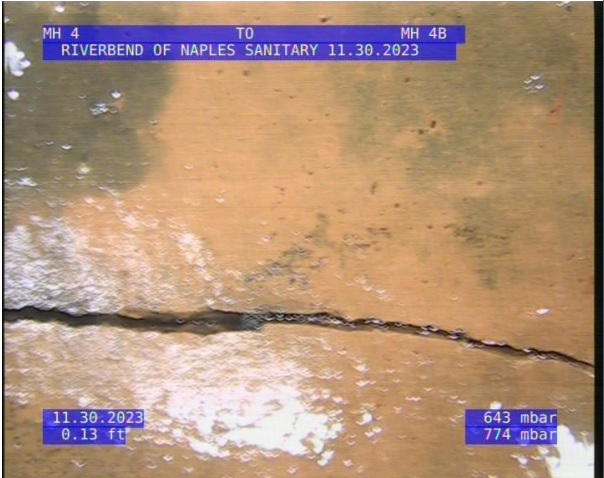
0.1	Crack Circumferential Position: 9 To 3 Severity: None Struct Weight: 1	01:23

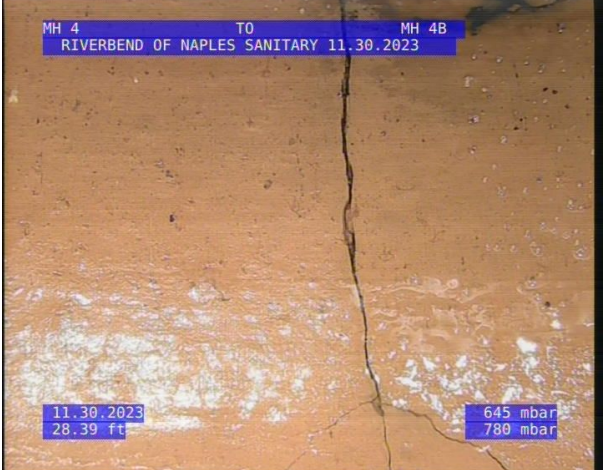
Distance	Fault Observation	Time	Picture
28.4	<p>Crack Longitudinal Position: 3 Severity: None Cont Defect: F02 Struct Weight: 2</p>	04:51

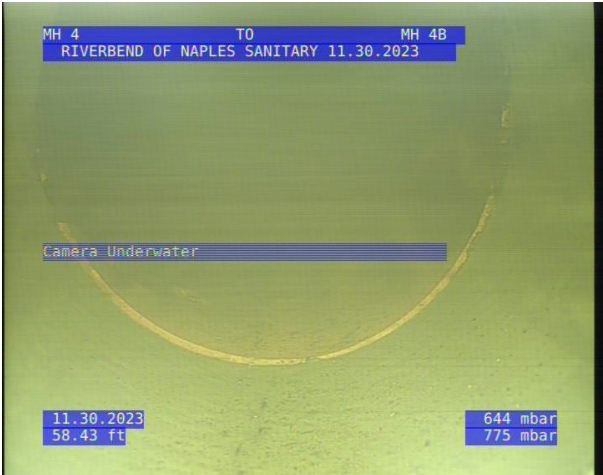
<p>MH 4 TO MH 4B RIVERBEND OF NAPLES SANITARY 11.30.2023</p> <p>11.30.2023 48.55 ft 646 mbar 778 mbar</p>
58.4	<p>Camera Underwater Severity: None Cont Defect: F03 Maint Weight: 4</p>	08:28

<p>MH 4 TO MH 4B RIVERBEND OF NAPLES SANITARY 11.30.2023</p> <p>Camera Underwater</p> <p>11.30.2023 58.43 ft 644 mbar 775 mbar</p>

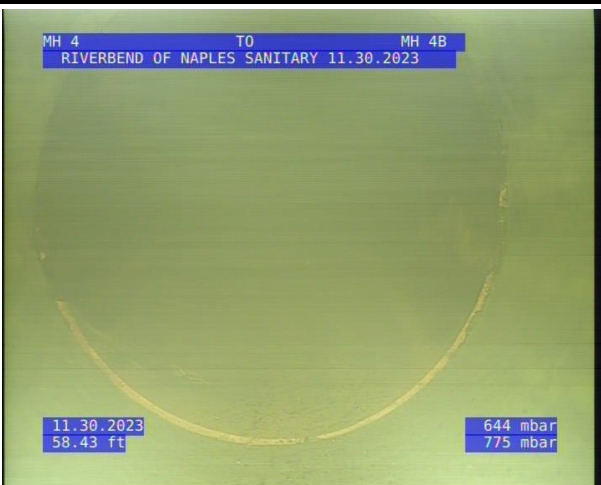
Distance	Fault Observation	Time	Picture
58.4	<p>Abandoned Survey Severity: None Remarks: UNDER WATER</p>	08:50
