# Project: RIVERBEND OF NAPLES SANITARY

## 11.30.2023

Pipe Segment Reference: MH-4B - MH-4

Material: Vitrified Clay Pipe

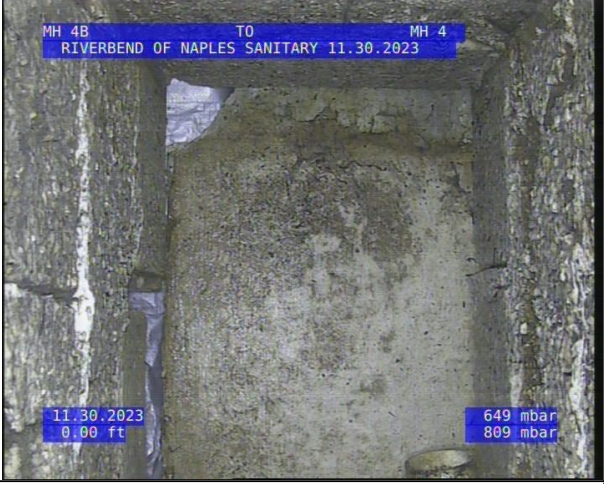
Distance	Fault Observation	Time	Picture
0.0	<b>Manhole</b> Severity: None Remarks: 4B	41

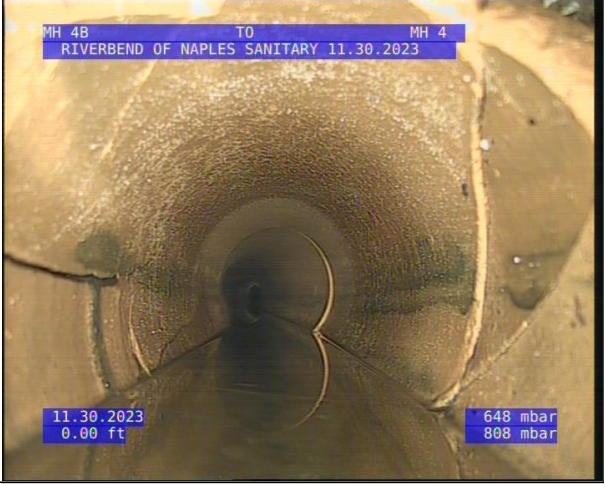
0.0	<b>Water Level</b> Severity: None Percent: 5	01:04

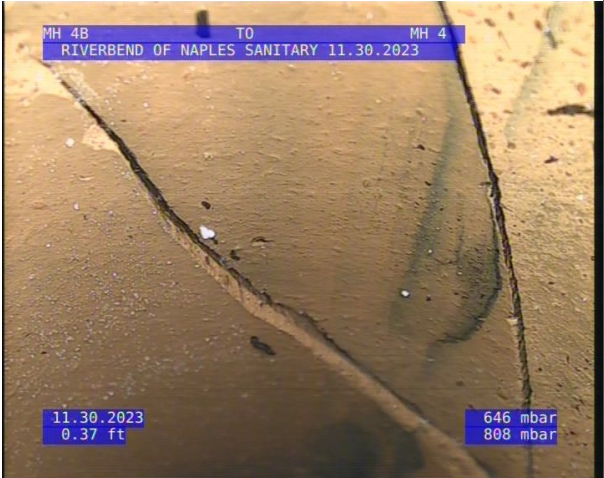
0.4	<b>Broken</b> Position: 1 To 3 Severity: None Struct Weight: 4	02:39

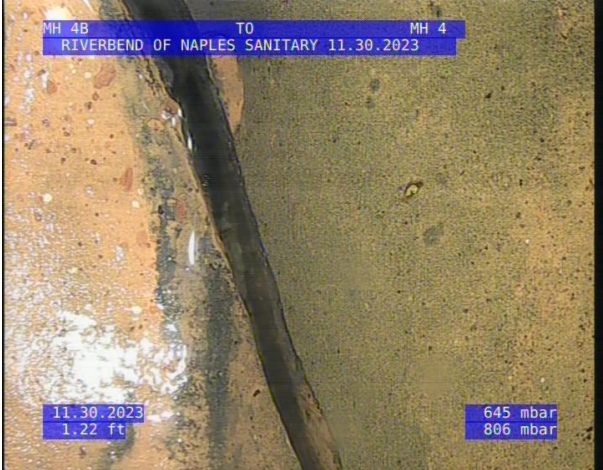
Distance	Fault Observation	Time	Picture
1.2	<b>Broken Void Visible</b> <b>Position: 3 To 9</b> <b>Severity: None</b> <b>Struct Weight: 5</b>	03:47

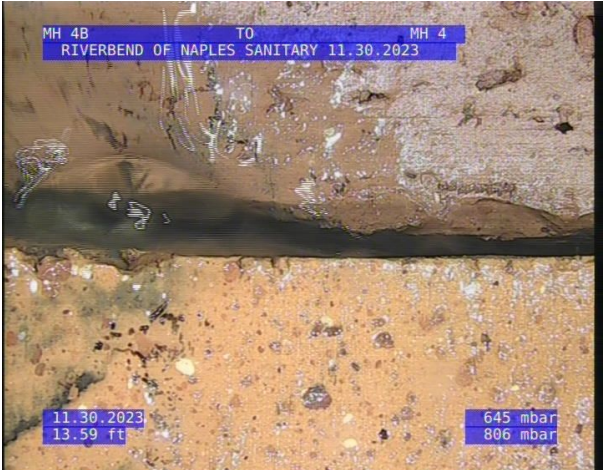
13.6	<b>Infil Runner</b> <b>Position: 5</b> <b>Severity: None</b> <b>Joint</b> <b>Maint Weight: 4</b>	05:16

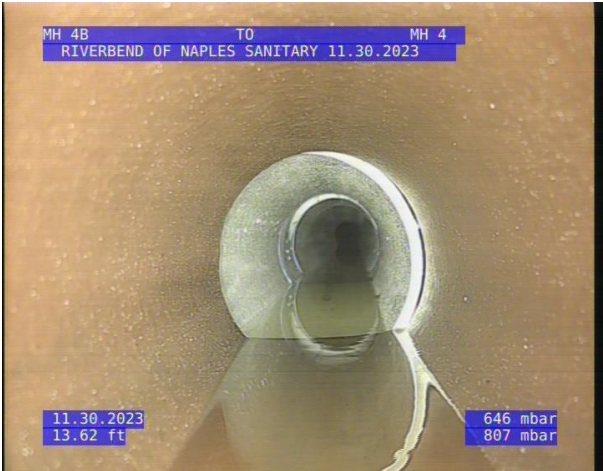
13.6	<b>Water Level Sag</b> <b>Severity: None</b> <b>Cont Defect: S01</b> <b>Percent: 10</b> <b>Struct Weight: 2</b>	06:07

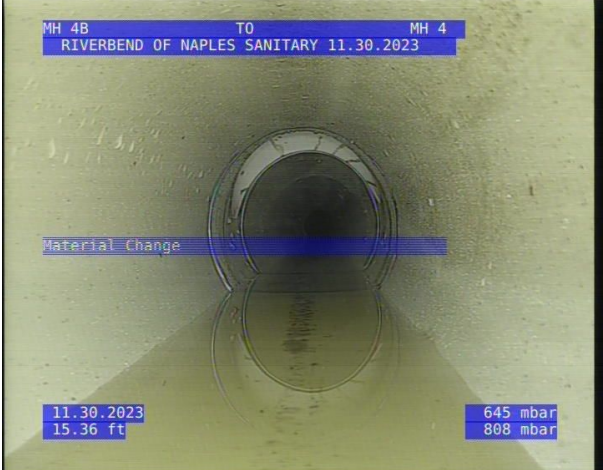
Distance	Fault Observation	Time	Picture
15.4	<b>Material Change</b> <b>Severity: None</b> <b>Remarks: PVC</b>	06:57

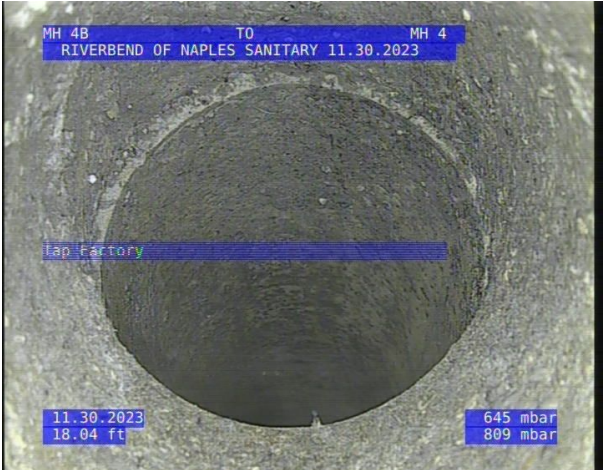
18.0	<b>Tap Factory</b> <b>Position: 12</b> <b>Severity: None</b> <b>Size: 6</b>	07:21

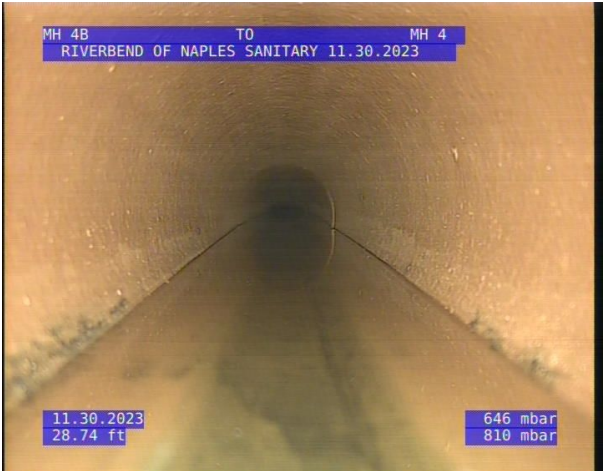
28.7	<b>Material Change</b> <b>Severity: None</b> <b>Remarks: VCP</b>	08:36
