# Project: RIVERBEND OF NAPLES SANITARY

## 11.30.2023

Pipe Segment Reference: MH-4 - C/O 4  
Upstream MH: C/O-4  
Downstream MH: MH-4  
Direction of Survey: Upstream  
Material: Polyvinyl Chloride

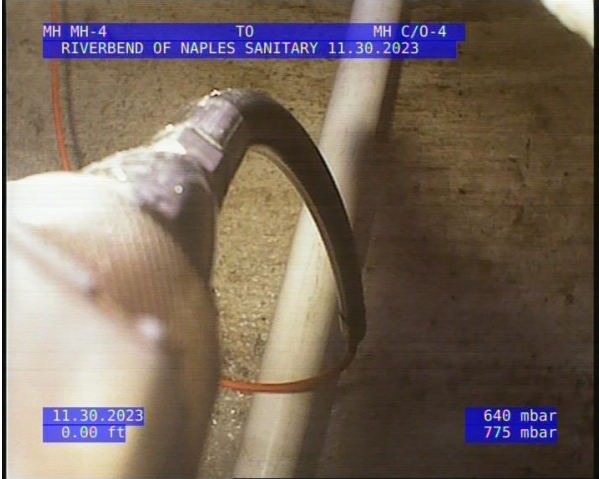
Distance	Fault Observation	Time	Picture
0.0	<b>Manhole</b> Severity: None Remarks: MH-4	24

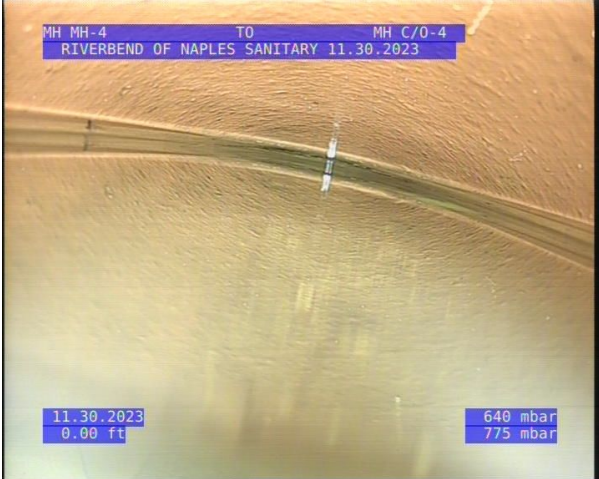
0.0	<b>Water Level</b> Severity: None Percent: 5	42

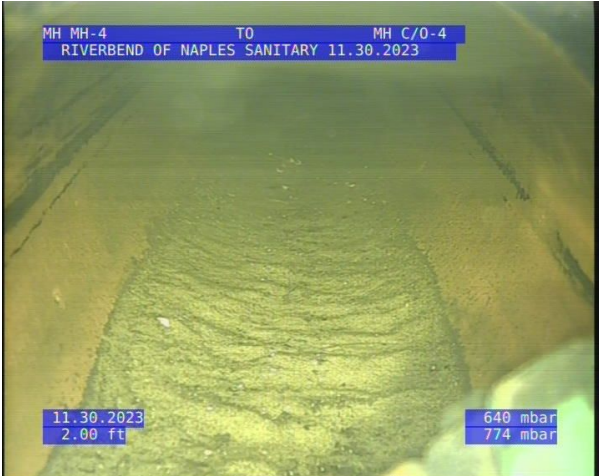
2.0	<b>Camera Underwater</b> Severity: None Maint Weight: 4	01:12
