Project: RIVERBEND OF NAPLES SANITARY

11.30.2023

Pipe Segment Reference: MH-1 - MH-4
Upstream MH: 1
Downstream MH: 4
Direction of Survey: Downstream
Material: Polyvinyl Chloride

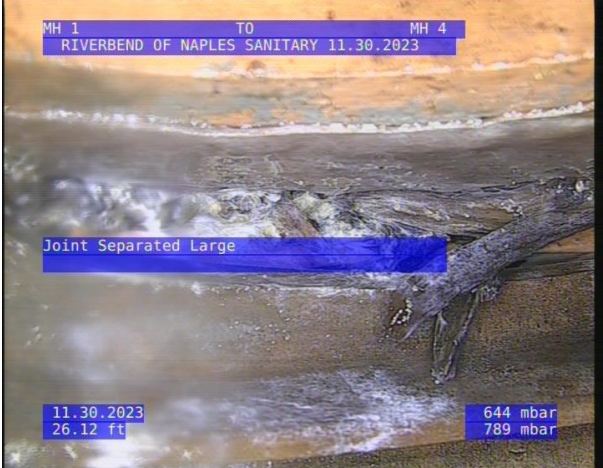
Distance	Fault Observation	Time	Picture
0.0	<p>Manhole Severity: None Remarks: 1</p>	01:01	
0.0	<p>Water Level Severity: None Percent: 5</p>	01:36	
6.1	<p>Tap Factory Position: 12 Severity: None Size: 6</p>	02:36

Distance	Fault Observation	Time	Picture
22.7	Material Change Severity: None Remarks: VCP	04:13	
25.9	Joint Offset Large Severity: None Remarks: INFIL DRIPPER Struct Weight: 2	05:29	
26.0	Abandoned Survey Severity: None Remarks: CANT MAKE IT PASS JOINT	07:39

Distance	Fault Observation	Time	Picture
26.1	<p>Joint Separated Large Severity: None Struct Weight: 2</p>	06:05

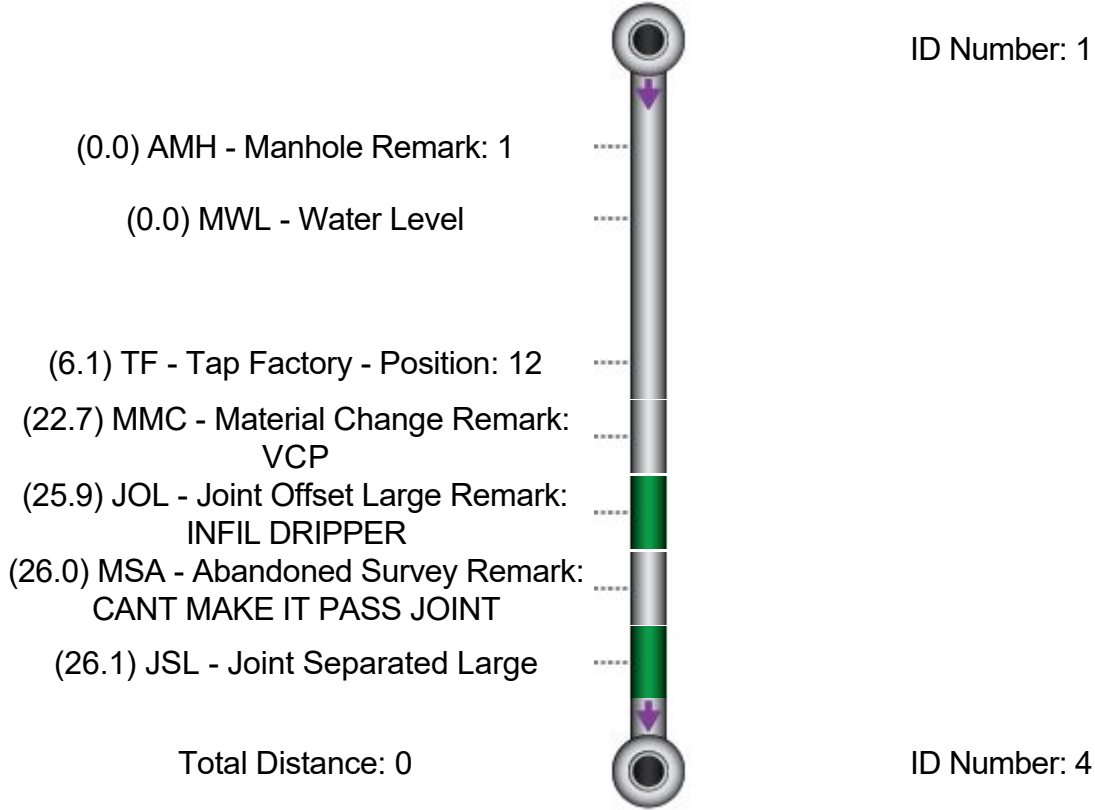
Nassco C.C.T.V. Defect Code Information

Grade	Structural	O&M	Overall
5	0	0	0
4	0	0	0
3	0	0	0
2	4	0	4
1	0	0	0
Overall	4	0	4
Number of Defects	2	0	2
Pipe Rating	2200	0000	2200
Pipe Ratings Index	2	0	2

Distance	Video Ref	Code	Cont Defect	Value			Joint	Circumferential Location	
				Dimension		%		At / From	To
				1st	2nd				
0	61	AMH - Manhole							
		1							
0	96	MWL - Water Level			5				
6.1	156	TF - Tap Factory		6			12		
22.7	253	MMC - Material Change							
		VCP							
25.9	329	JOL - Joint Offset Large							
		INFIL DRIPPER							
26	459	MSA - Abandoned Survey							
		CANT MAKE IT PASS JOINT							
26.1	365	JSL - Joint Separated Large

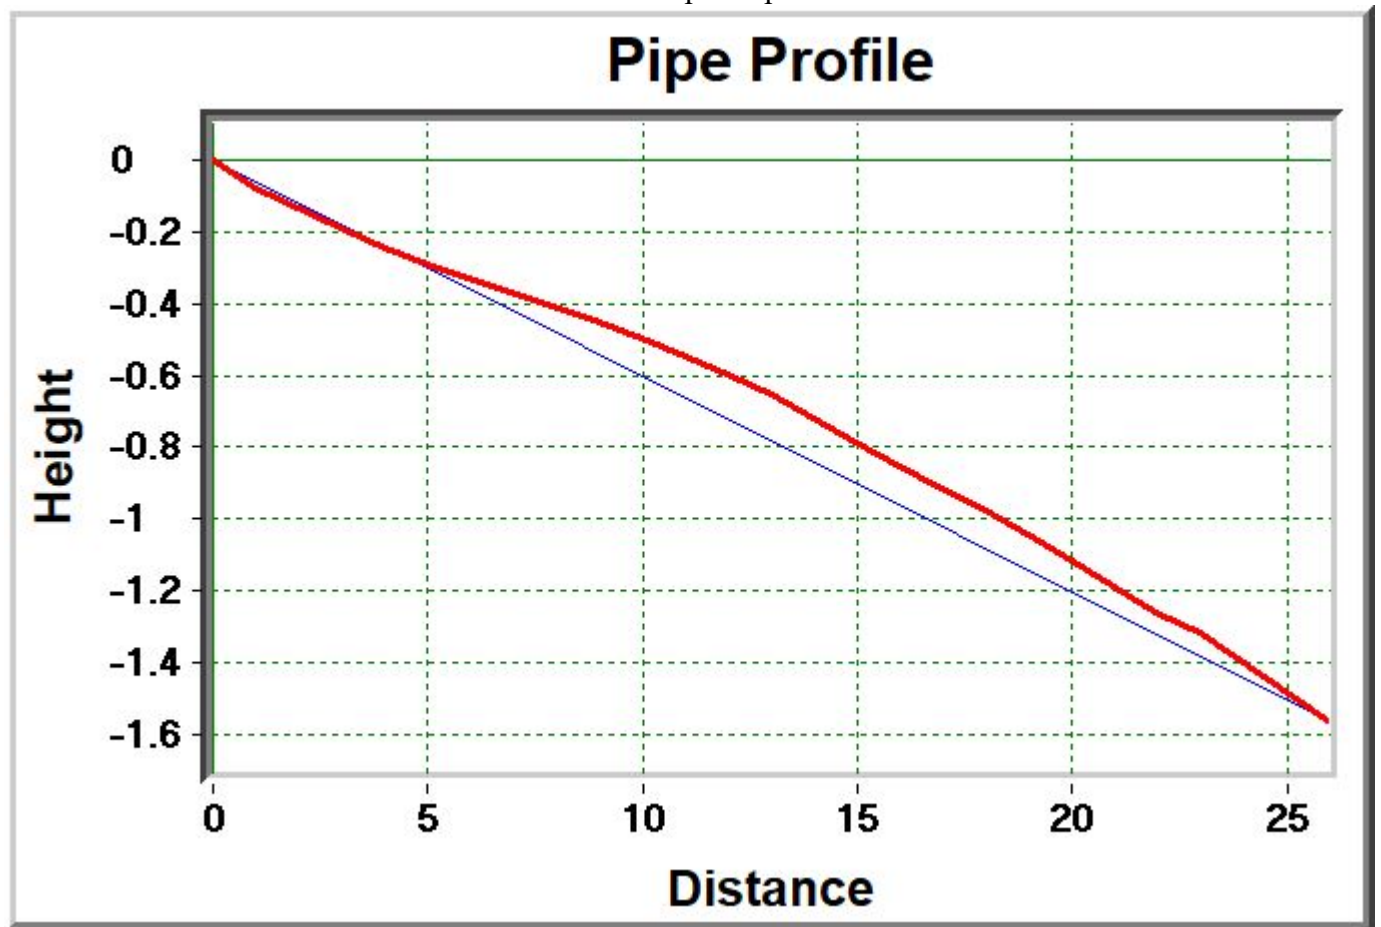
Percent Grade Mean: -6.15

Plot Distance From: 0 To 1

Max Percent Difference: 3

Number of Window Values: 1

Percent Difference Max for Windows Values: 60

Number of Feet to Average: 1

Final number of points plotted: 21
