Project: RIVERBEND OF NAPLES SANITARY

11.30.2023

Pipe Segment Reference: MH-4 - LS
 Upstream MH: 4
 Downstream MH: LIFT STATION
 Direction of Survey: Downstream
 Material: Polyvinyl Chloride

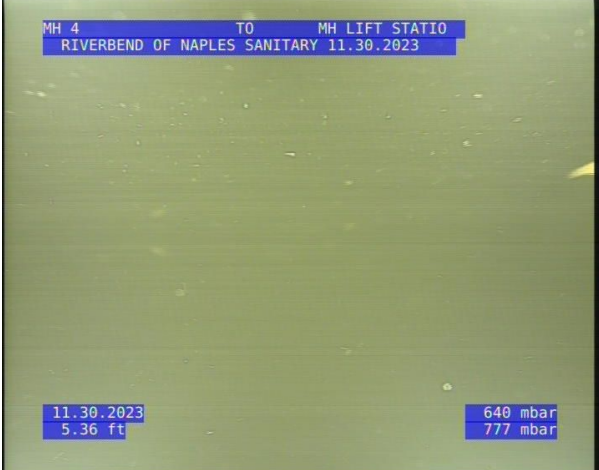
Distance	Fault Observation	Time	Picture
5.4	<p>Camera Underwater Severity: None Cont Defect: S02 Maint Weight: 4</p>	01:52

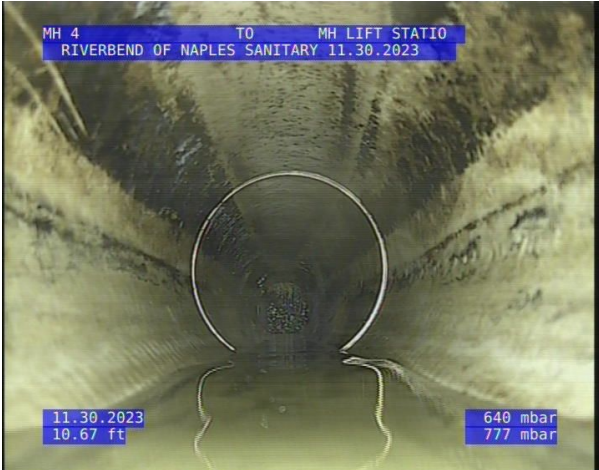
10.7	<p>Camera Underwater Severity: None Cont Defect: F02 Maint Weight: 4</p>	02:09

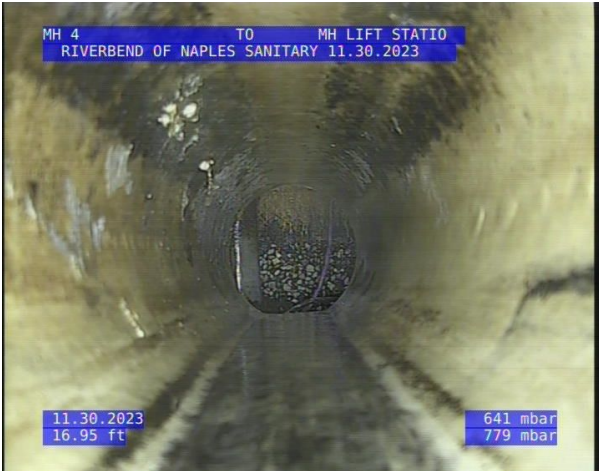
17.0	<p>Water Level Sag Severity: None Cont Defect: F01 Percent: 15 Struct Weight: 2</p>	02:51

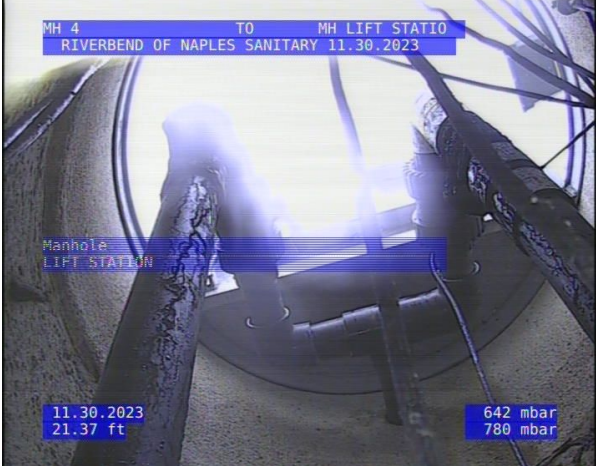
Distance	Fault Observation	Time	Picture
21.4	<p align="center"> Manhole Severity: None Remarks: LIFT STATION </p>	03:14

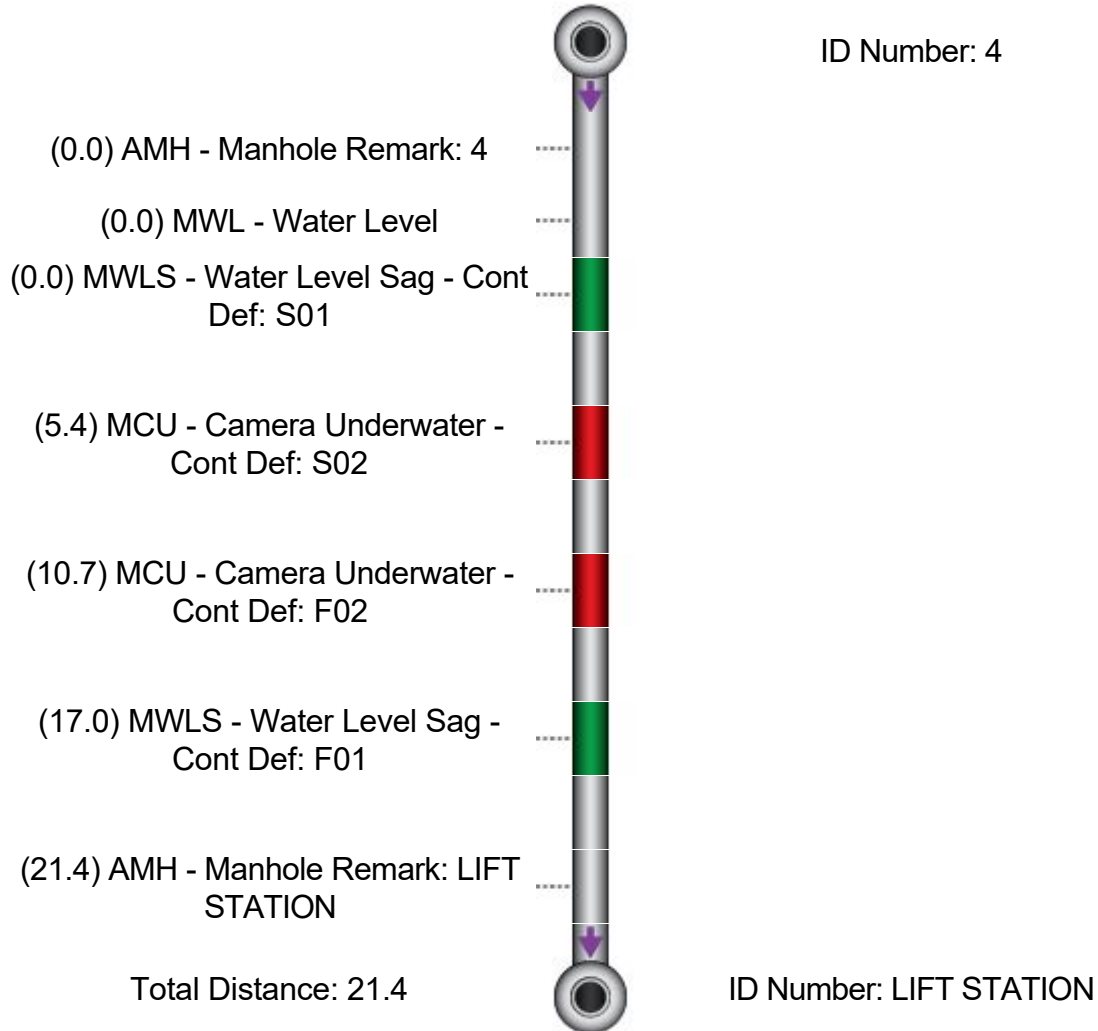
Nassco C.C.T.V. Defect Code Information

Severity
Light
Moderate
Average
Heavy
Severe

Grade	Structural	O&M	Overall
5	0	0	0
4	0	4	4
3	0	0	0
2	6	0	6
1	0	0	0
Overall	6	4	10
Number of Defects	3	1	4
Pipe Rating	2300	4100	4123
Pipe Ratings Index	2	4	2

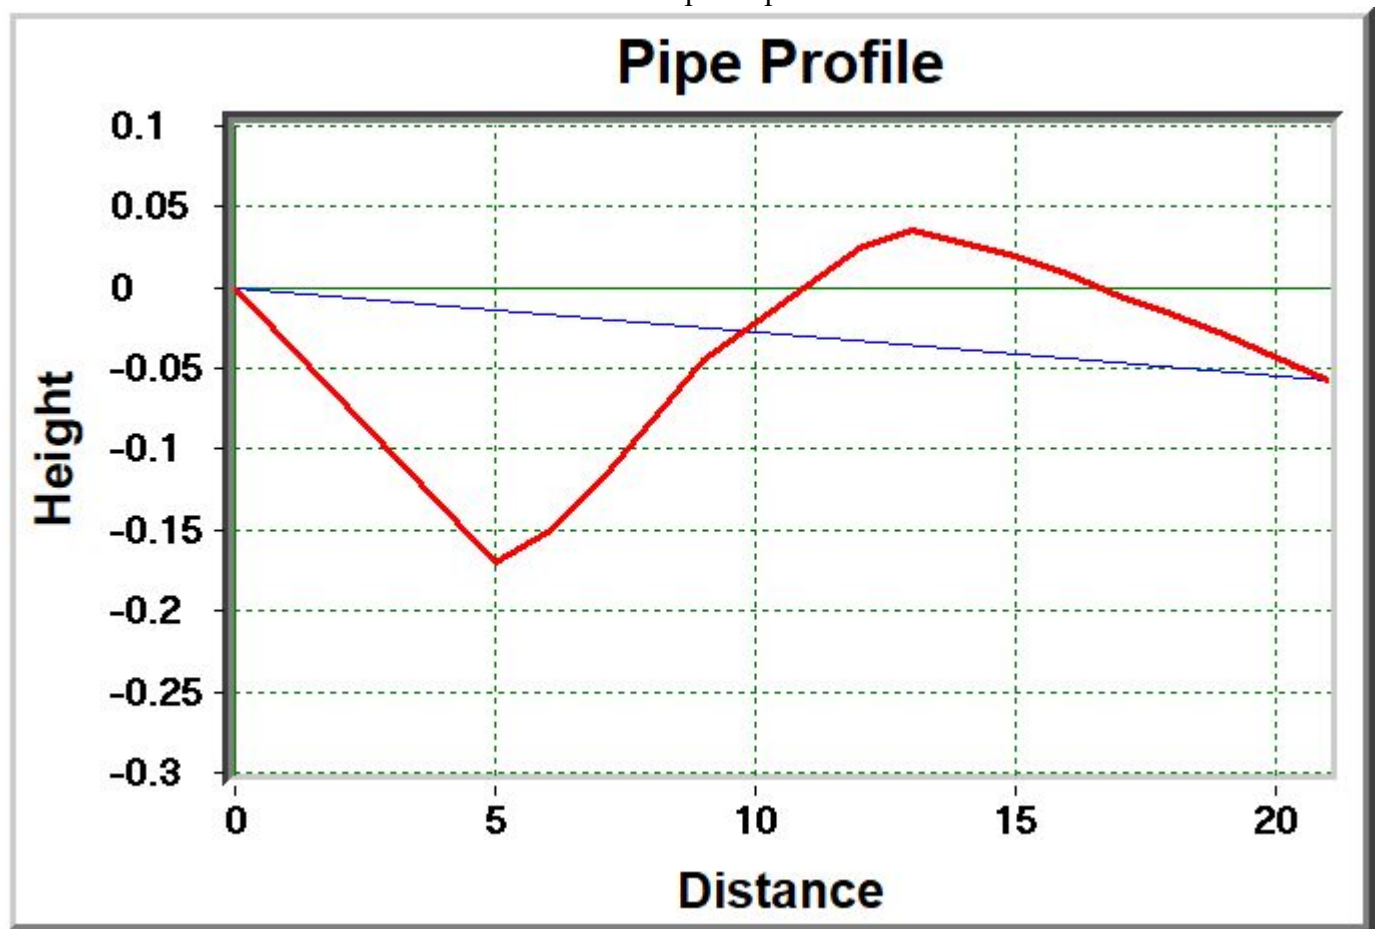
Percent Grade Mean: 0.09
Plot Distance From: 0 To 22
Max Percent Difference: 3
Number of Window Values: 1
Percent Difference Max for Windows Values: 60
Number of Feet to Average: 1
Final number of points plotted: 13
