Project: RIVERBEND OF NAPLES SANITARY

11.29.2023

Pipe Segment Reference: MH-1B - MH-1
Upstream MH: 1B
Downstream MH: 1
Direction of Survey: Downstream
Material: Polyvinyl Chloride

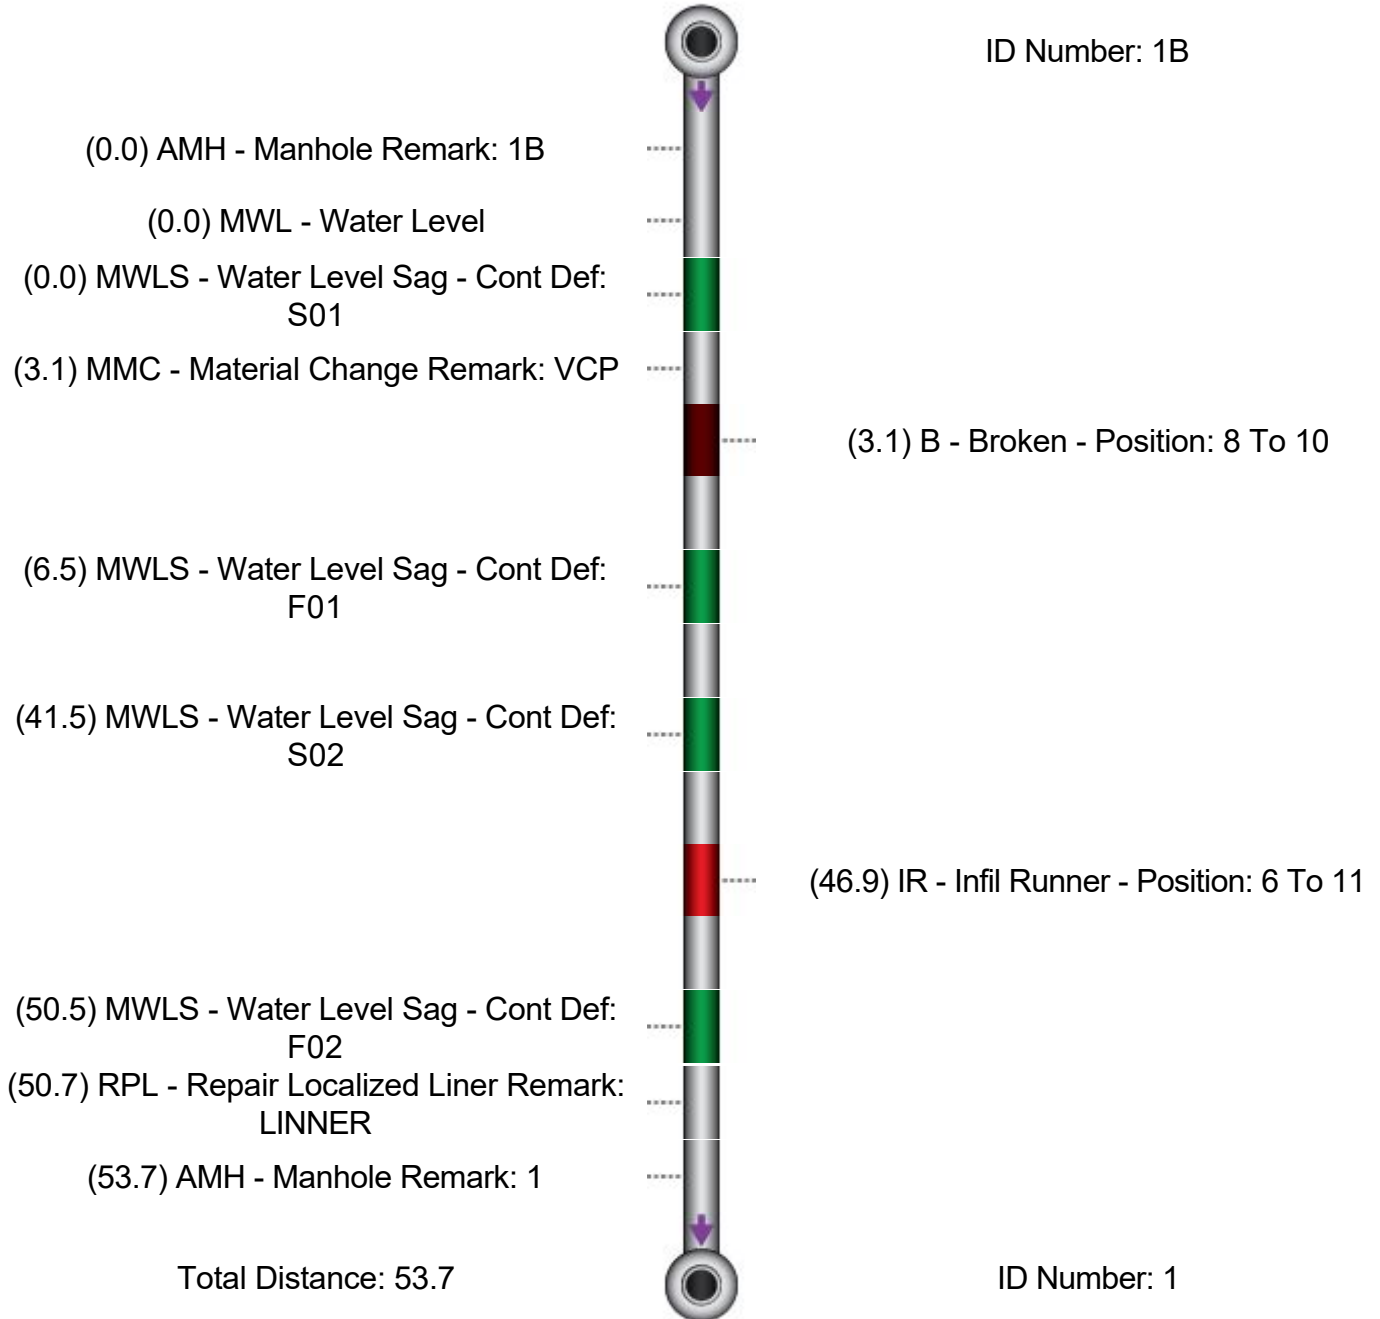
Nassco C.C.T.V. Defect Code Information

Grade	Structural	O&M	Overall
5	5	0	5
4	0	4	4
3	0	0	0
2	6	0	6
1	0	0	0
Overall	11	4	15
Number of Defects	4	1	5
Pipe Rating	5123	4100	5141
Pipe Ratings Index	3	4	3

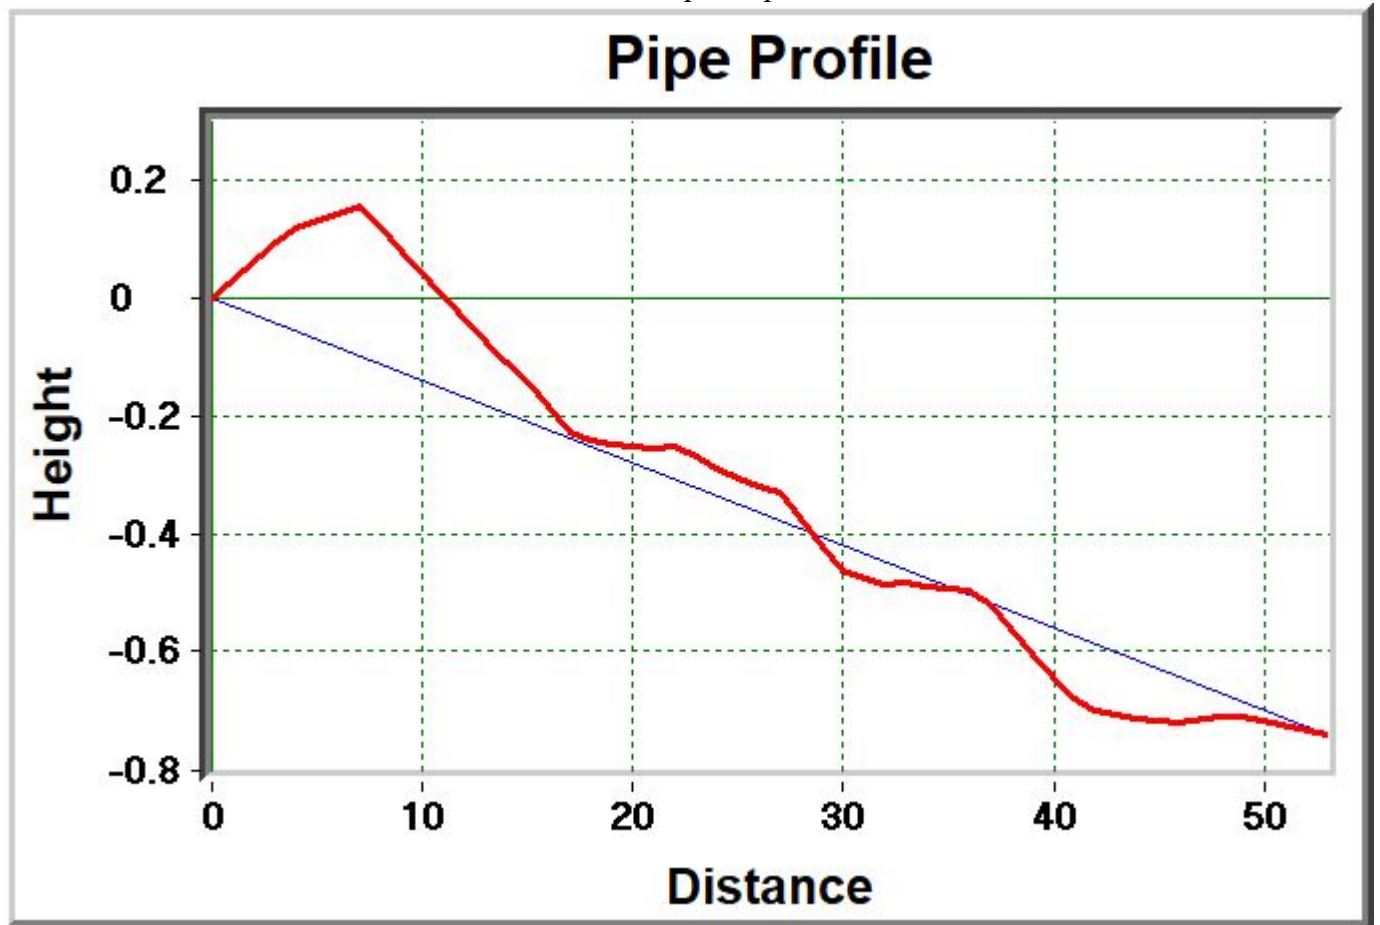
Percent Grade Mean: -1.40

Max Percent Difference: 3
