# Project: RIVERBEND OF NAPLES SANITARY

## 11.29.2023

**Pipe Segment Reference:** MH 1B - C/O-2  
**Upstream MH:** C/O 2  
**Downstream MH:** 1B  
**Direction of Survey:** Upstream  
**Material:** Vitrified Clay Pipe

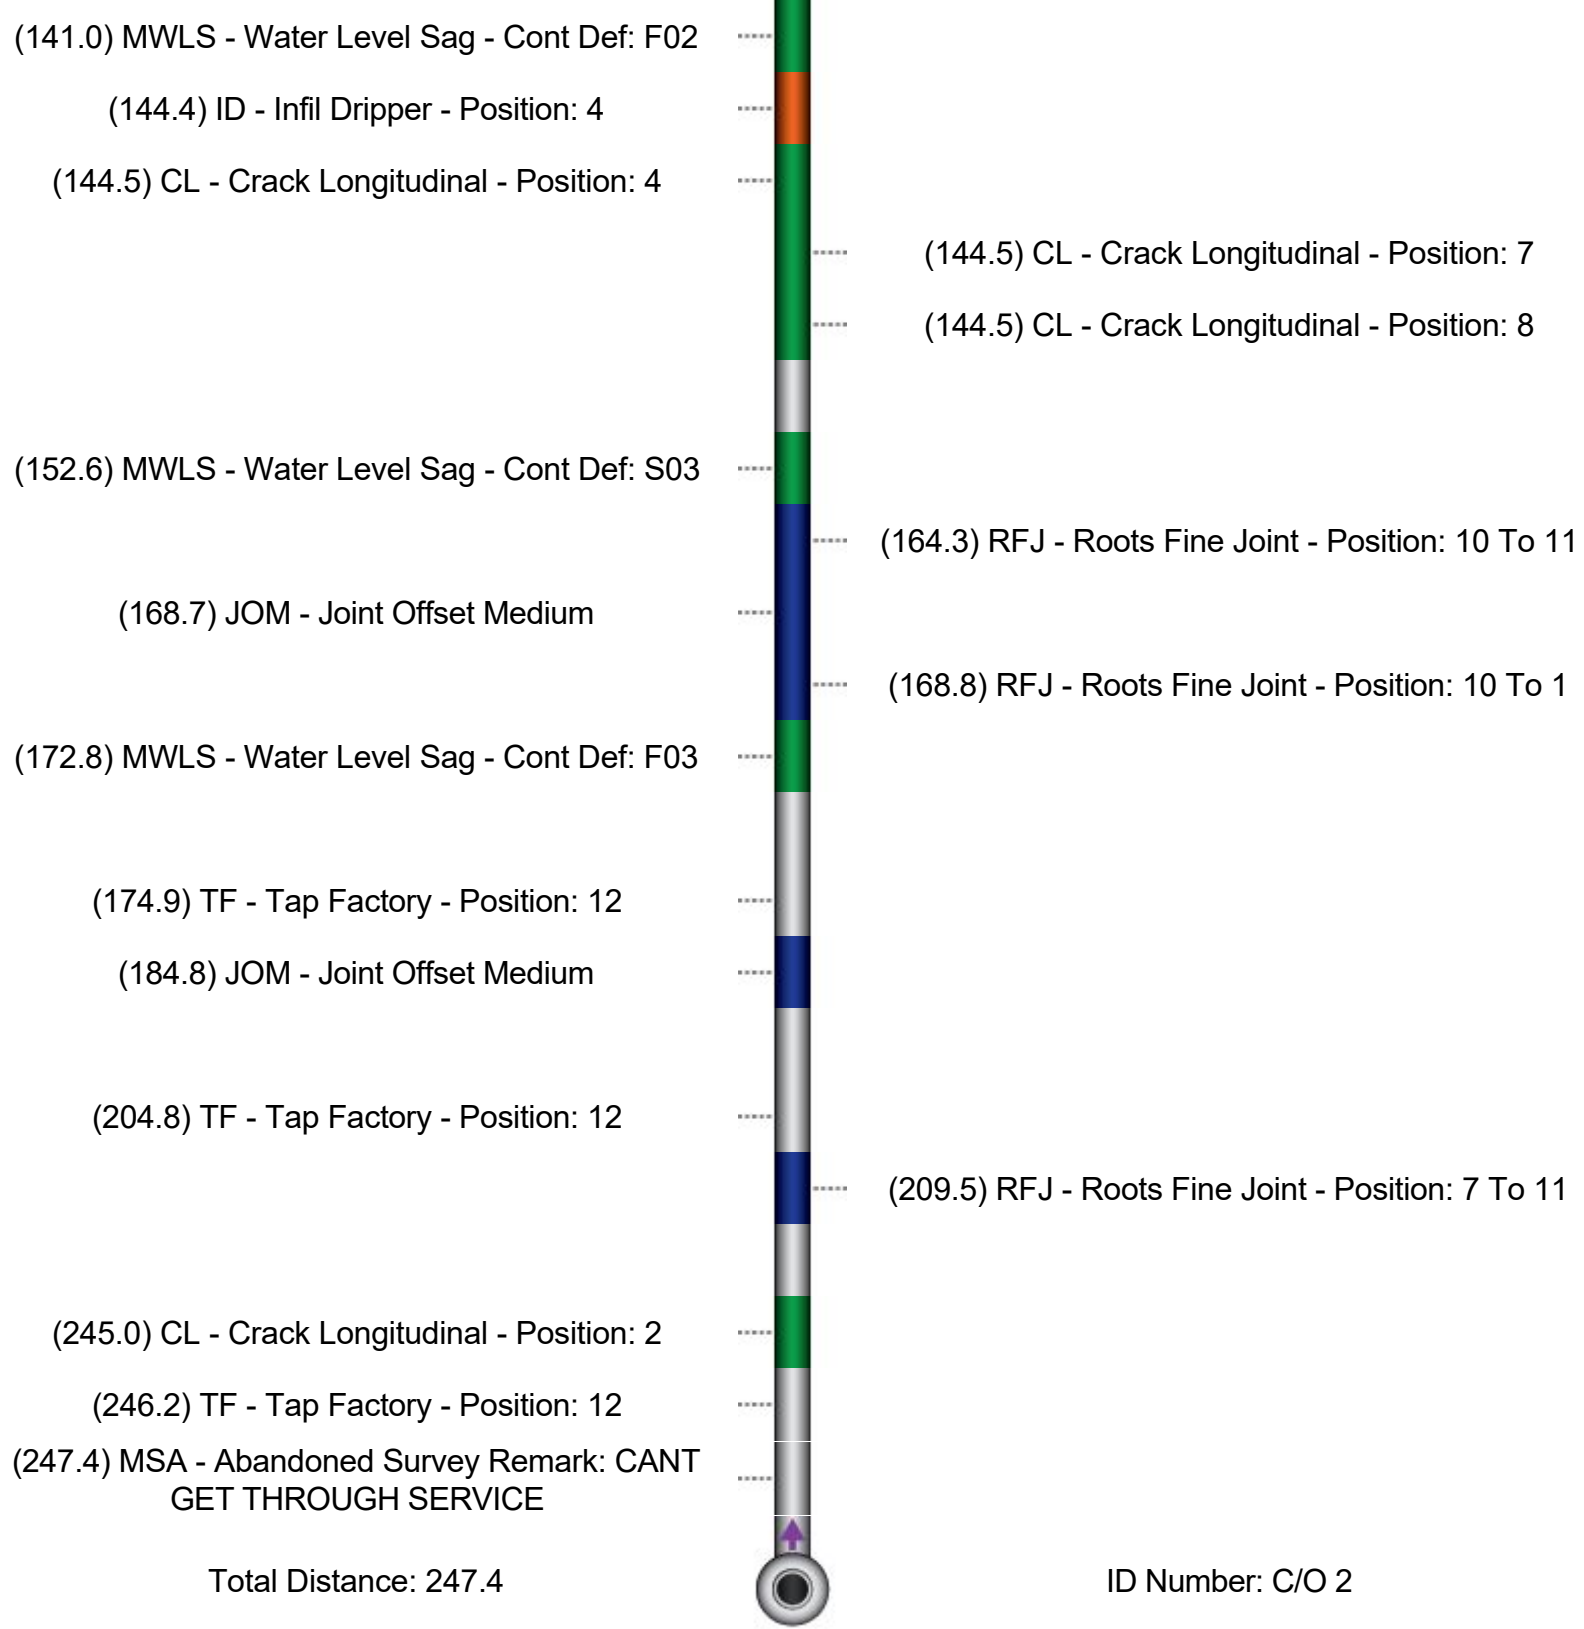
(138.5) RFJ - Roots Fine Joint - Position: 10 To 12

138.5	1287	RFJ - Roots Fine Joint					X	10	
141	1326	MWLS - Water Level Sag	F02			5			
144.4	1407	ID - Infil Dripper					X	4	
144.5	1465	CL - Crack Longitudinal						4
