# Project: RIVERBEND OF NAPLES SANITARY

## 11.30.2023

Pipe Segment Reference: MH-4B - MH-4

Material: Vitrified Clay Pipe

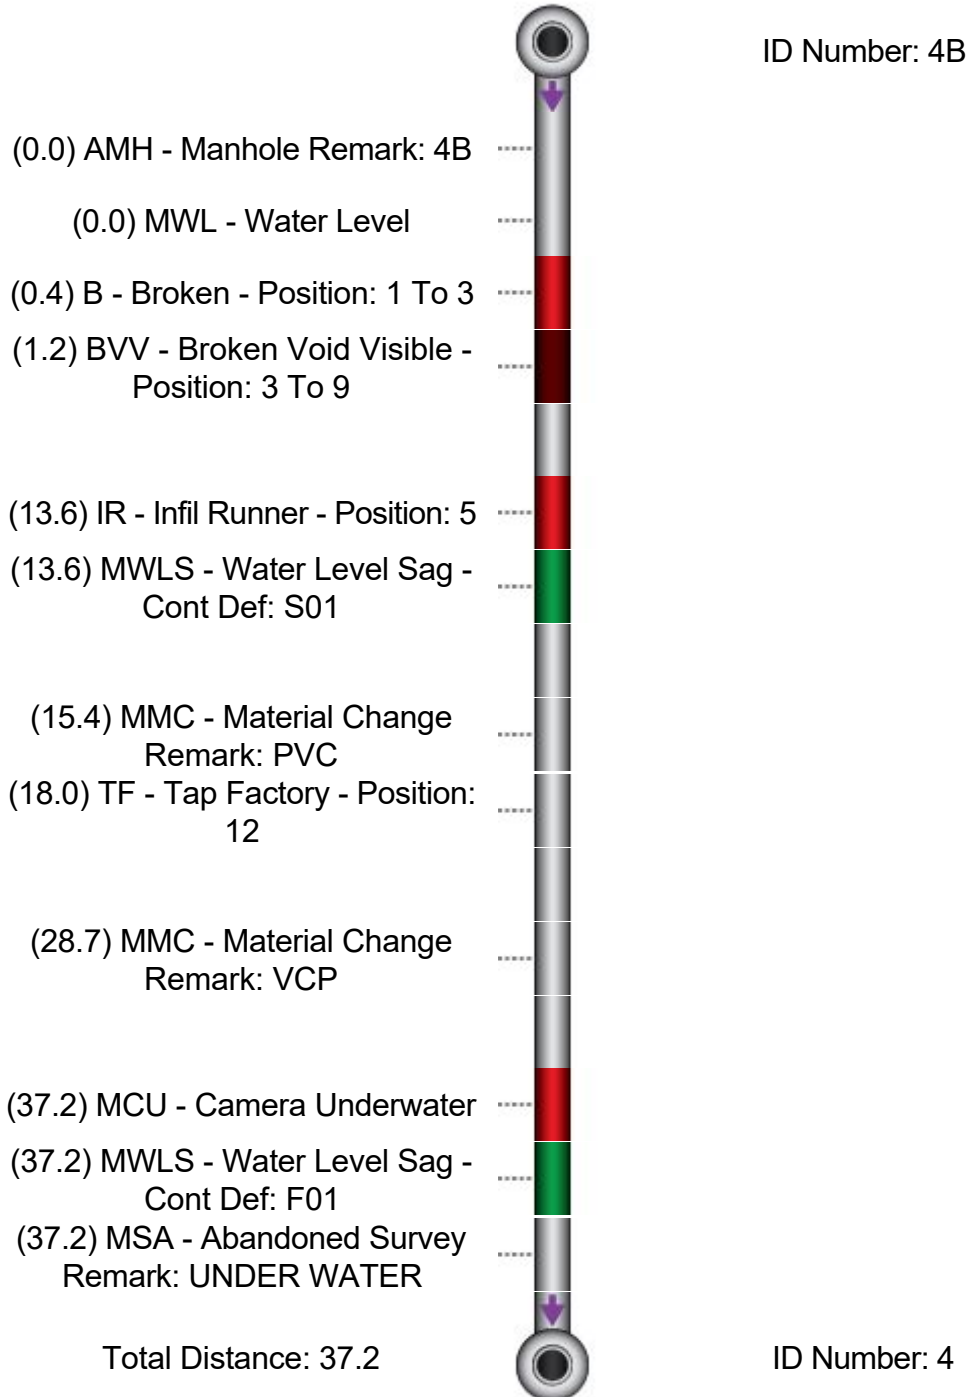
0.4	<b>Broken</b> Position: 1 To 3 Severity: None Struct Weight: 4	02:39

Distance	Fault Observation	Time	Picture
1.2	<b>Broken Void Visible</b> <b>Position: 3 To 9</b> <b>Severity: None</b> <b>Struct Weight: 5</b>	03:47

13.6	<b>Water Level Sag</b> <b>Severity: None</b> <b>Cont Defect: S01</b> <b>Percent: 10</b> <b>Struct Weight: 2</b>	06:07

Distance	Fault Observation	Time	Picture
37.2	<b>Camera Underwater</b> <b>Severity: None</b> <b>Maint Weight: 4</b>	09:45	
37.2	<b>Water Level Sag</b> <b>Severity: None</b> <b>Cont Defect: F01</b> <b>Percent: 10</b> <b>Struct Weight: 2</b>	09:53	
37.2	<b>Abandoned Survey</b> <b>Severity: None</b> <b>Remarks: UNDER WATER</b>	10:43

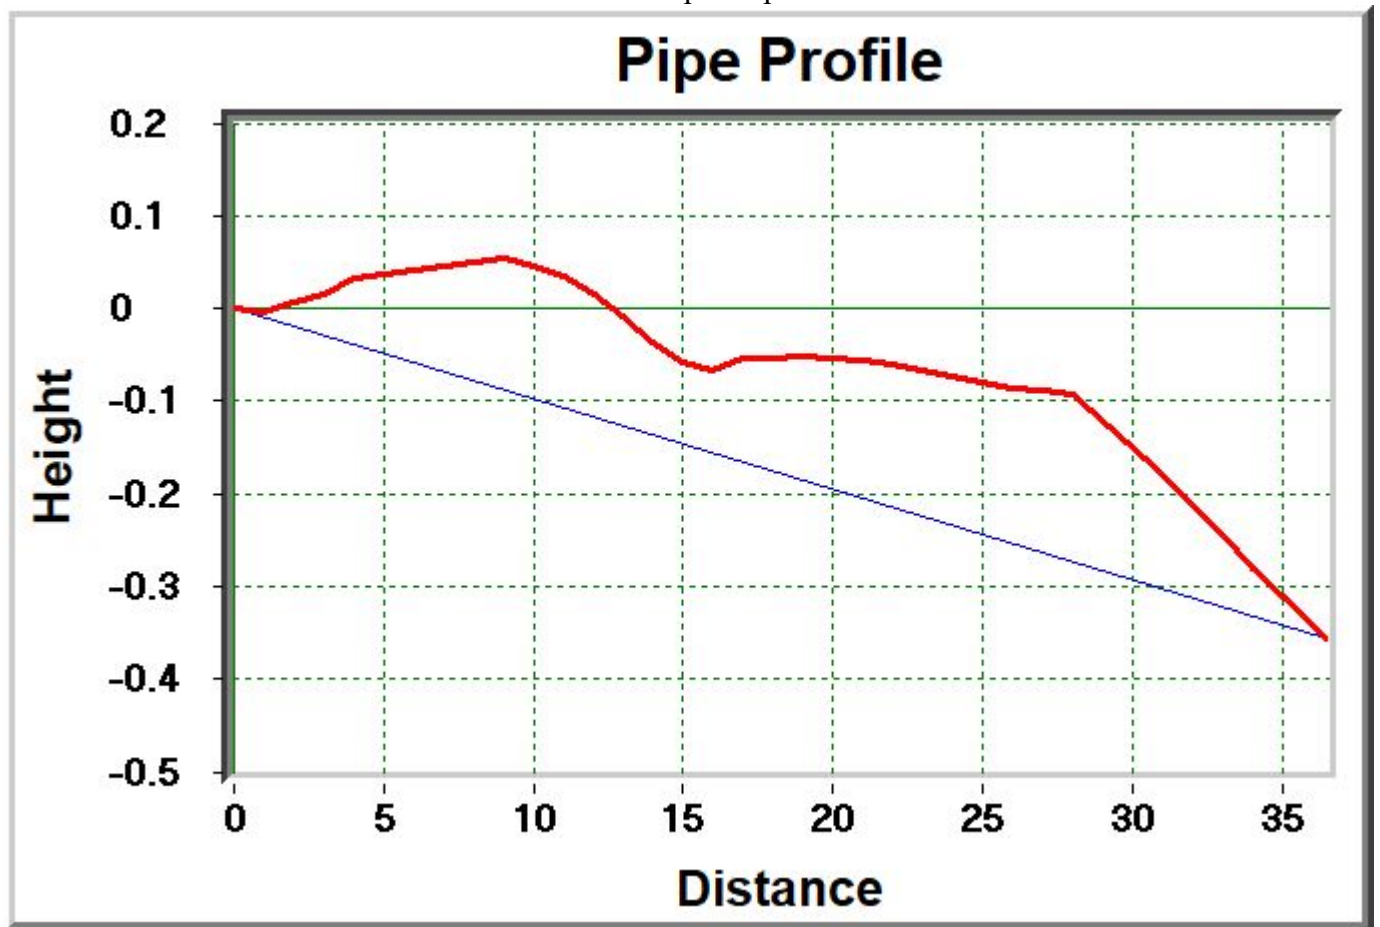
Percent Grade Mean: -0.84

Max Percent Difference: 3
