# Project: RIVERBEND OF NAPLES SANITARY

## 11.30.2023

Pipe Segment Reference: MH-4 - C/O 4  
Upstream MH: C/O-4  
Downstream MH: MH-4  
Direction of Survey: Upstream  
Material: Polyvinyl Chloride

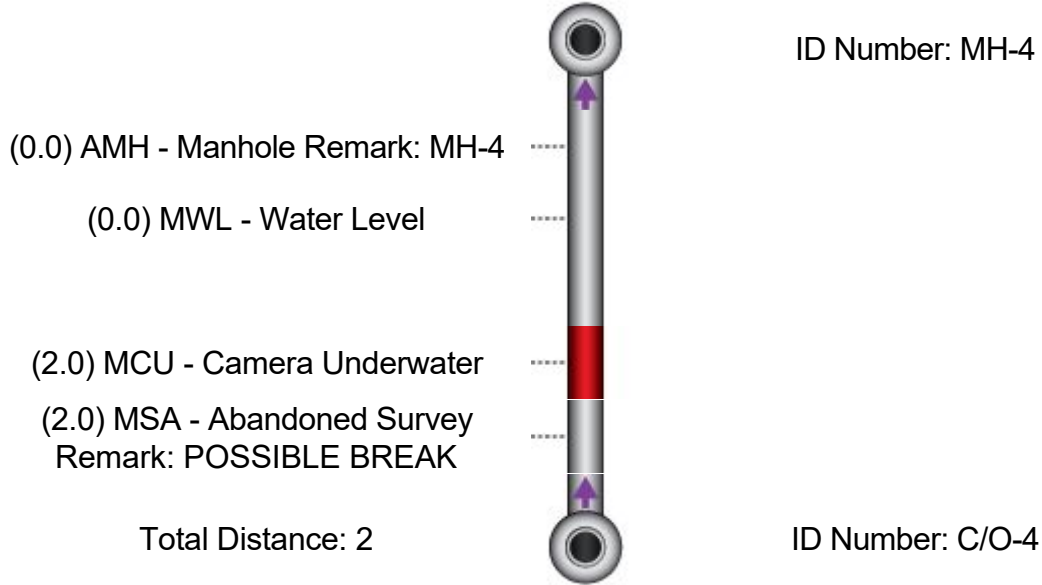
Distance	Video Ref	Code	Cont Defect	Value			Joint	Circumferential Location	
				Dimension		%		At / From	To
				1st	2nd				
0	24	AMH - Manhole							
		MH-4							
0	42	MWL - Water Level			5				
2	72	MCU - Camera Underwater							
2	148	MSA - Abandoned Survey							
		POSSIBLE BREAK
